**CONDITION & VALUE SURVEY**

***M/V 65' Pacific Mariner***

**Report #:** 20-191  
**Date:** Xxxx, XX, 2020  
**Owner:** Big Boat LLC,  
**Survey Requested By:** Steve Smith, [bmelbo@comcast.net](mailto:bmelbo@comcast.net)  
**Broker(s)**  
**Where Surveyed:** Sausalito Yacht Harbor & Keefe, Kaplan, Maritime, INC, in Richmond, CA  
**Afloat/Hauled:** Afloat & while hanging in the Travelift slings  
**Vessel Name:** XXX CCCCC  
**Type:** Pilothouse power cruiser  
**Service:** Private/pleasure  
**Home Port:** Tiburon, CA  
**Photo of Official#**  
**Official #:** XXXXXXXX  
**Photo of HIN**  
**Hull ID#:** XXXXXXXXXX  
**Builder:** Westport  
**Designer:** William Garden  
**Model:** 65' Pacific Mariner  
**Model Year:** 2006  
**Date Last Hauled:** 2019  
**LOA:** 65' 0" on deck (70' LOA)  
**Beam:** 17' 3"  
**Draft:** 5' 0"  
**Displacement:** 69,000 Lbs.  
**Vessel Color Scheme:** White topsides & decks, black stripes

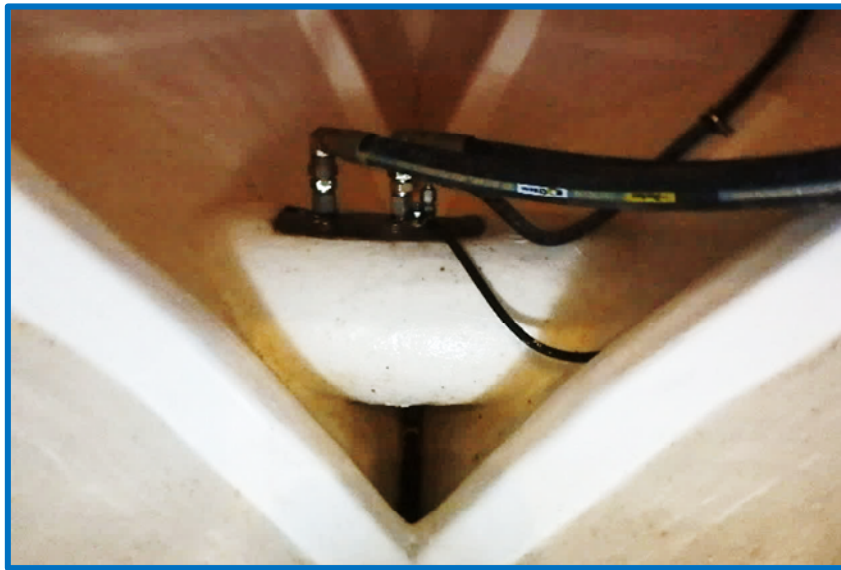
For internal reinforcements, the vessel relies upon marine plywood bulkheads bonded to the hull, fiberglass molded longitudinal stringers, and transverse frames. The hull-to-deck joint is a vertical overlapping flange, which is fastened and bonded. A thorough inspection of the interior and its structural sub-assemblies revealed no movement, failed secondary bonds, or soft or decayed wood. There are at least three water-tight bulkheads are aboard the vessel. The aft engine compartment bulkhead is equipped with a watertight door, which latched securely, and its gaskets appeared to be sealing well. Much of the interior is sealed in with liners, cabinetry, and tanks, making complete inspection impossible.

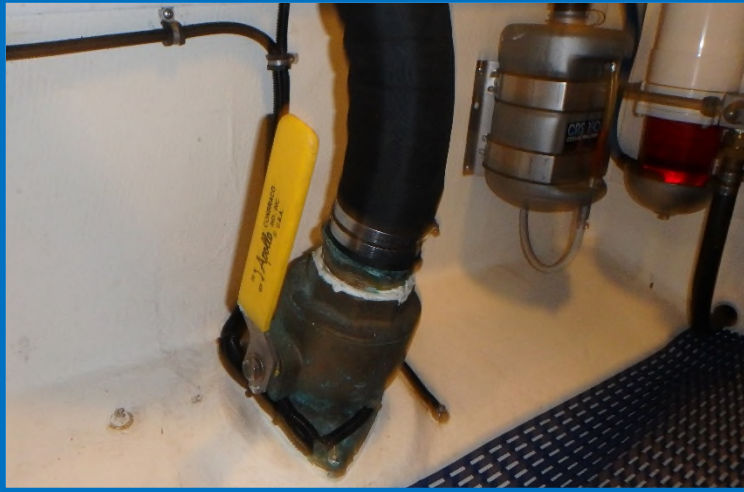
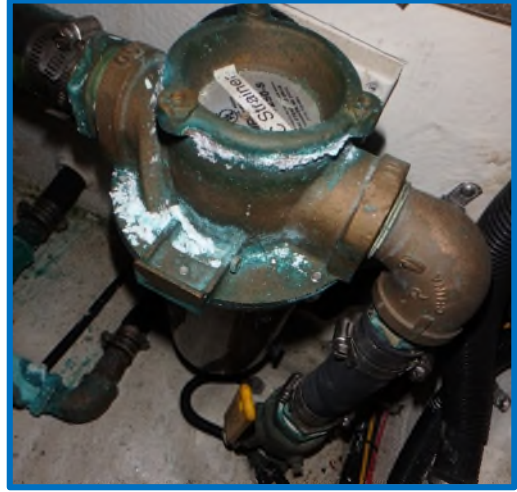
For sea-connections, the vessel relies mostly upon Apollo bronze flanged seacocks, coupled to threaded bronze through hulls. There were a few of the seacocks that the surveyor could not close easily, and they were found frozen or partially frozen (see sea-connection table on page #3). Otherwise, inspection of the sea-connections showed them in operable and satisfactory condition.

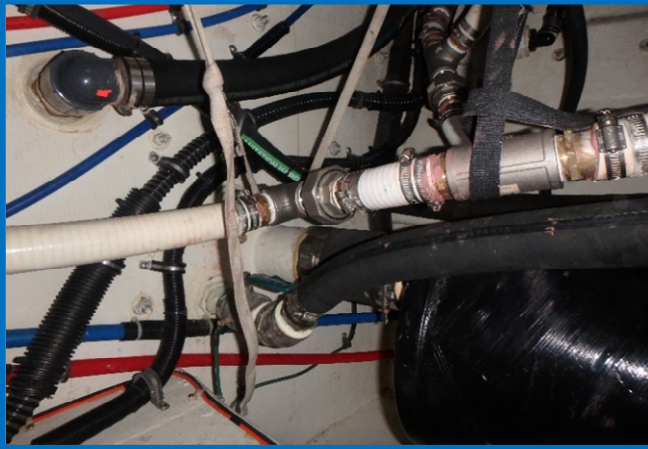
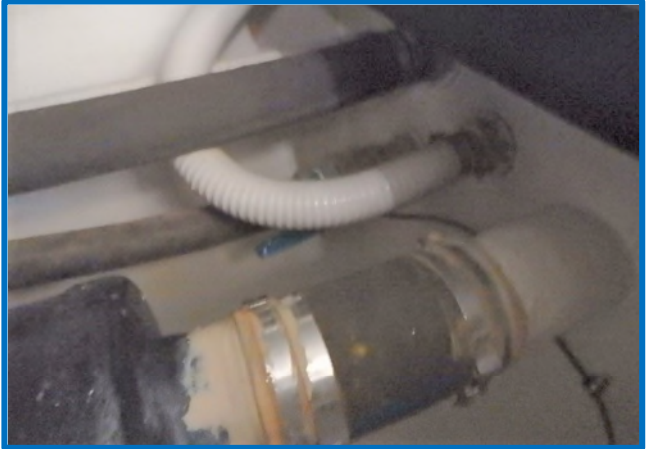
A few of the through hulls located in the crew cabin were not fitted with shutoff valves, as recommended by the guidelines of American Boat Council's H-27 Seacocks, Thru-Hull Fittings & Drain Plugs:

*H-27.5.1 All piping, tubing, or hose lines penetrating the hull below the maximum heeled waterline, shall be equipped with a seacock to stop the admission of water in the event of failure of pipes, tubing, or hose.*

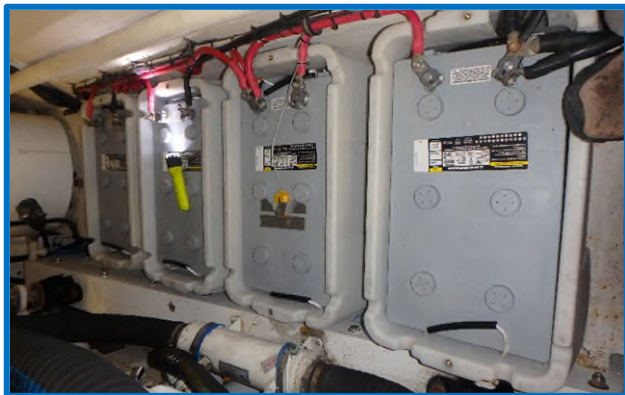
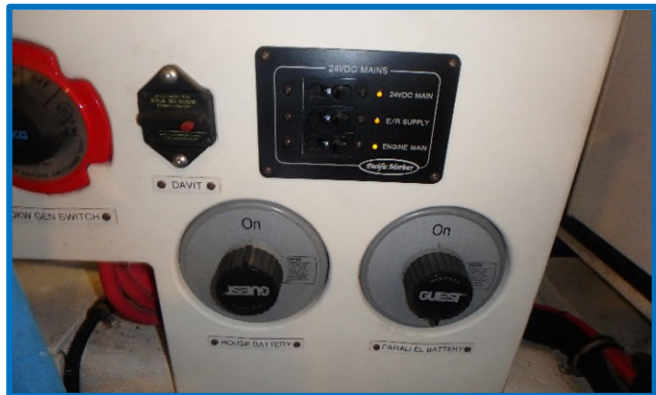
There are two separate DC electrical systems aboard the vessel. The house electrical system is powered via four West Marine 12-volt 8D 225 AH Gel type batteries, which are wired in series/parallel to make a 24-volt bank, and routed through the Guest vapor-tight battery switch, and the various DC distribution panelboards. The second DC electrical system is dedicated to engine starting; likewise, it's powered by two 12-volt West Marine 8D 225 amp-hour Gel type batteries, wired in series to make a 24-volt bank, and routed through the Guest vapor-type battery switch, and the engines' wiring harnesses. The two battery banks can be paralleled with a third Guest vapor-tight battery switch. The electronic navigation equipment is 12-volts, and suspected to be powered by a 24-volt to 12-volt DC converter, and is routed through a separate distribution panelboard. The converter was not viewed.

The batteries are satisfactorily and securely installed within Blue Sea Systems acid-proof boxes. The batteries were in good condition, without case anomalies, bulging, or cracking. The DC primary cabling consists tinned marine battery cable. Inspection of the primary cabling, the terminals and connections showed them secure, and free of corrosion.

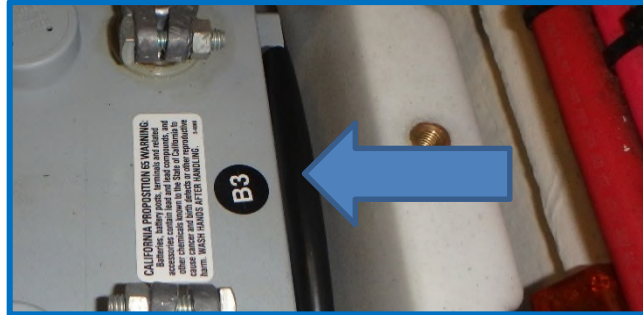
Several of the batteries had date stamps indicating they were installed in 2013. The vessel's Captain reported all the batteries were replaced roughly 3 or 4 years ago. It is typical marine industry practice to replace deep-cycle batteries upon 7- to 10-year cycles, depending on their care, charging profiles, maintenance, usage, and discharge cycles. Upon any indication of low voltage or charging anomalies, replacing the house batteries is suggested. At the time of the inspection, the batteries were charging normally and showed normal voltage levels.

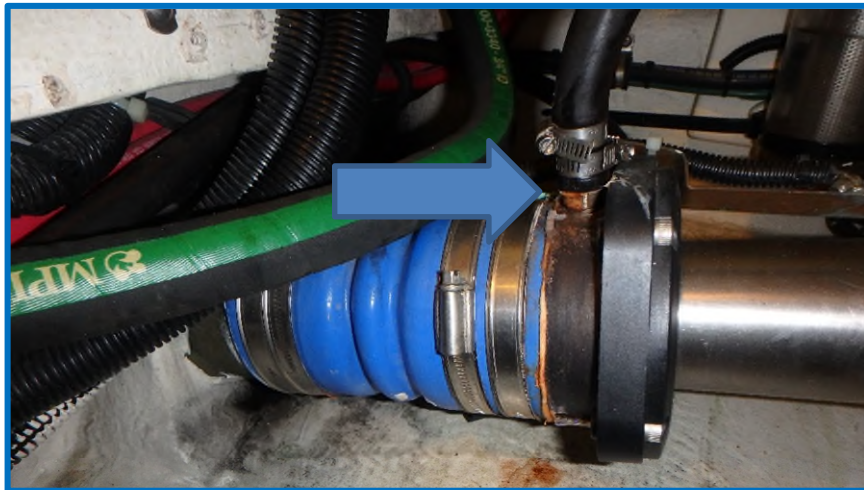
The propeller shafts rely upon Tides Marine dripless water injection shaft seals. The seals were observed during the sea-trial, and the port side was actively leaking with the propeller shaft turning. The starboard seal was slightly moist. Furthermore, there were some indications of rust staining on the seals' bodies, and their water injection nipples. Servicing or replacing the shaft seals, per the manufacturer's recommendations is recommended.

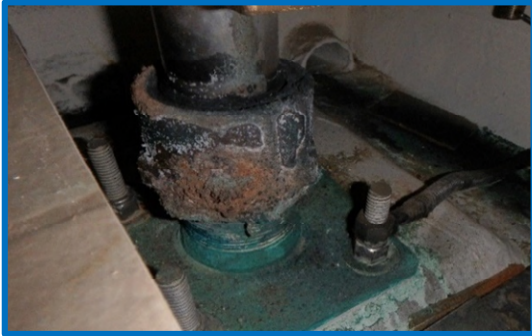
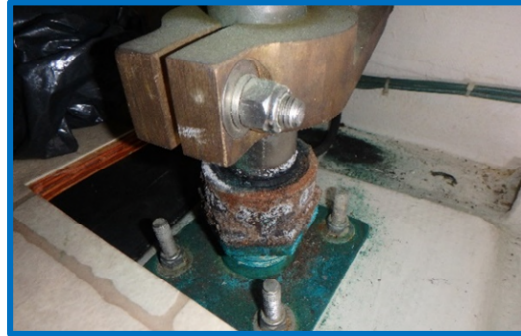
However, both glands' packing nuts showed unusual cosmetic surface rusting, and a few sodium deposits on their tops. Cleaning the packing nuts to bright bronze is suggested. The Simrad hydraulic autopilot was tested from both stations during the sea-trial; it steered the vessel on a true course, and responded to course changes reliably.

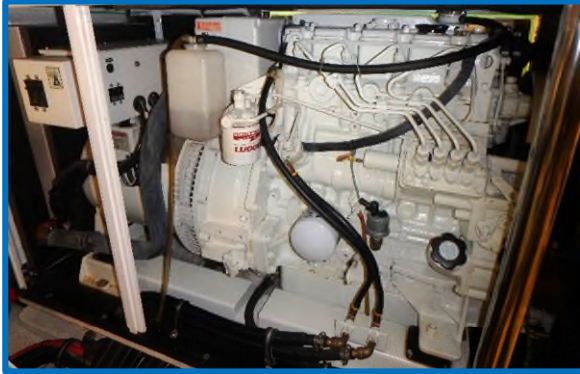
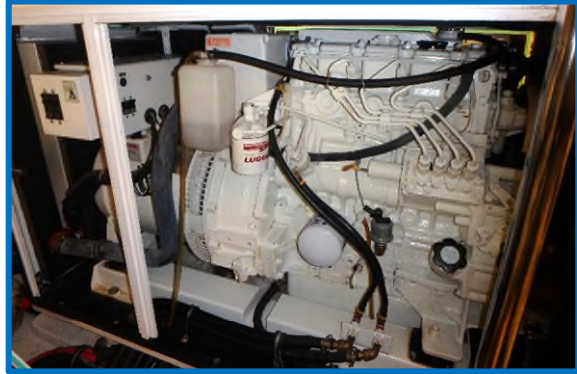
The vessel's 20 KW and 16 KW generators were found in good cosmetic condition, with their factory installed anticorrosive coatings free of failures. The generators' sound shields and their sound proofing were well secured, and free of coating failures. The generators' oil was checked, and it was found topped off and clean in both units. The 20 KW generator's coolant was at the low mark in its saddle tank when cold. The 16 KW generator was at the full mark. Monitoring the coolant levels and assuring it meets the manufacturer's recommendations is suggested. Inspection of the generators' water scrubbing exhaust showed minor cracking of the following hard wall marine exhaust hoses:

These hoses should be scheduled for replacement in the near future. Furthermore, areas of both generator's exhaust systems are concealed and could not be fully inspected by the surveyor. Performing a thorough examination of the generators' exhaust systems, and repairing or replacing as deemed necessary is suggested.

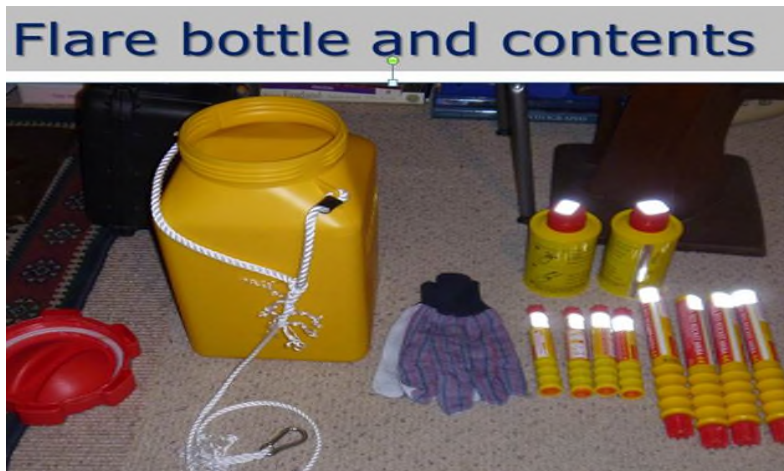
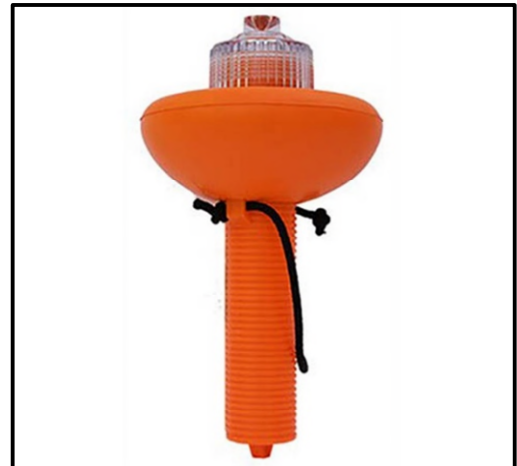
This photo shows a well-organized visual distress signal kit, and waterproof storage container. Including protective gloves and safety glasses. Note the dangerous ends of the flares are marked with reflective tape. Smoke or day signals, and handheld night signals, should be part of a complete flare kit. Additionally, white collision flares that can be displayed to bring attention to your vessel if it is not seen on radar or AIS of a large or commercial vessel, and also useful for lighting up the area in a MOB situation. It is important to treat flares with respect, store them well, and purchase SOLAS or LED flares. The USCG now approves electronic LED flares near shore. Carrying these LED flares should be considered, instead of traditional pyrotechnics. Pyrotechnic flares are extremely difficult to dispose of and have expiry dates.
