BILL MELBOSTAD, CMS Worldwide Marine Surveys, Ltd.

CONDITION & VALUE SURVEY

S/V COMPAÑERA II

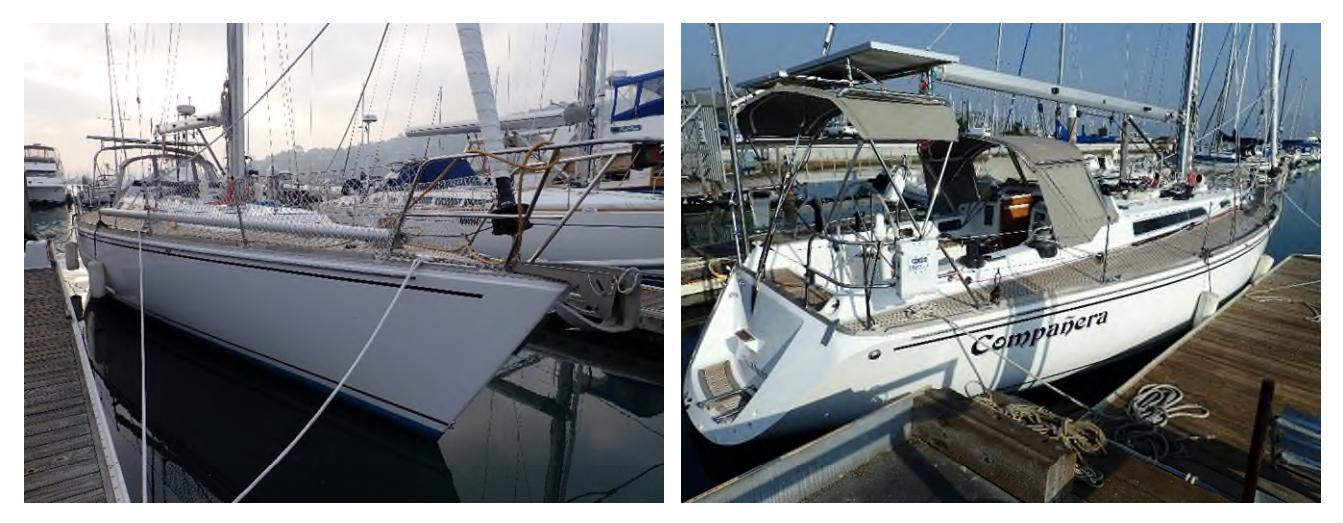
The deck layout consists of a tee-shaped self-bailing cockpit protected by a dodger and a bimini top, flush side and fore decks with a slight crown, and a raised blister trunk cabin. There is a recessed anchor locker fitted with a windlass. The cockpit, deck, and cabin structures are constructed with alternating layers of molded fiberglass, with closed cell foam cores in places for reinforcements. The cockpit seats, sole, and the side and fore decks have a solid teak plank overlay, traditionally fastened with stainless steel sheet metal screws. Visual inspection of the structures showed them without indications of physical harm or damage, or signs of previous repairs. Visual inspection of the teak plank overlay revealed the following cosmetic and minor anomalies:

- 1. There is very minor and normally expected wear on the planking, and slightly raised grain.
- 2. There are roughly 10 missing teak bungs, leaving the fastener heads exposed.
- 3. There is an open seam, where the outboard starboard plank mid-ships is damaged for roughly 5" along the seam. This may be a tool mark, and done during the deck's installation.
- 4. There is a very thin split, roughly 18" long, in the 5th plank from the shear on the port side of the foredeck, just behind the anchor locker.
- 5. There is a ~3" long groove in the plank just outboard and adjacent to the port jib lead's Harken adjustable car.

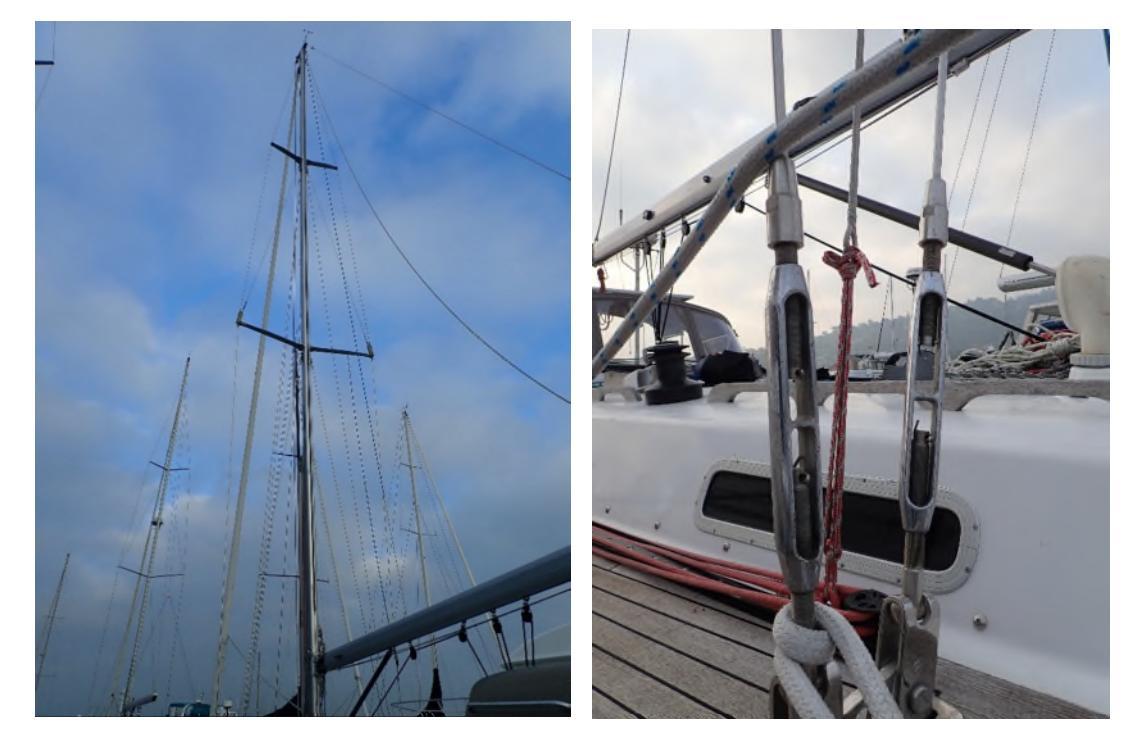
The mast, the boom, and the standing and running rigging were inspected both at deck-level and aloft. As reported by the prospective buyer, the mast was unstepped at Driscoll Boat Works in August 2018, to repair a transverse crack on the mast's aft side, just below the gooseneck. The repair was completed by the subcontractor, Rig Works in San Diego, and involved installing a mechanical sleeve to reinforce the cracked area of the mast extrusion. A thin crack was still evident at the sight of the repair. The coatings should be removed to determine the depth of the crack, and whether it is structurally significant.

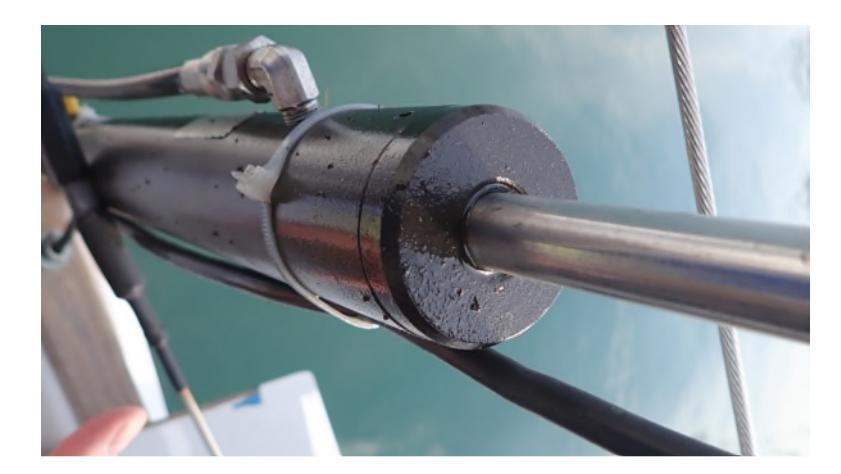
The vessel is equipped with a hydraulic adjustable backstay, outhaul, and hydraulic vang, all manufactured by Navtec. When the backstay was tensioned, its hydraulic experienced very minor bleed-off of pressure, and hydraulic fluid was seeping from the cylinder's top seal. The outhaul and the vang were not tested; their hydraulic cylinders were serviced recently. As discussed, servicing the Navtec hydraulic system will become more difficult, since the company no longer is in business, and replacement and service parts will become increasingly difficult to purchase.

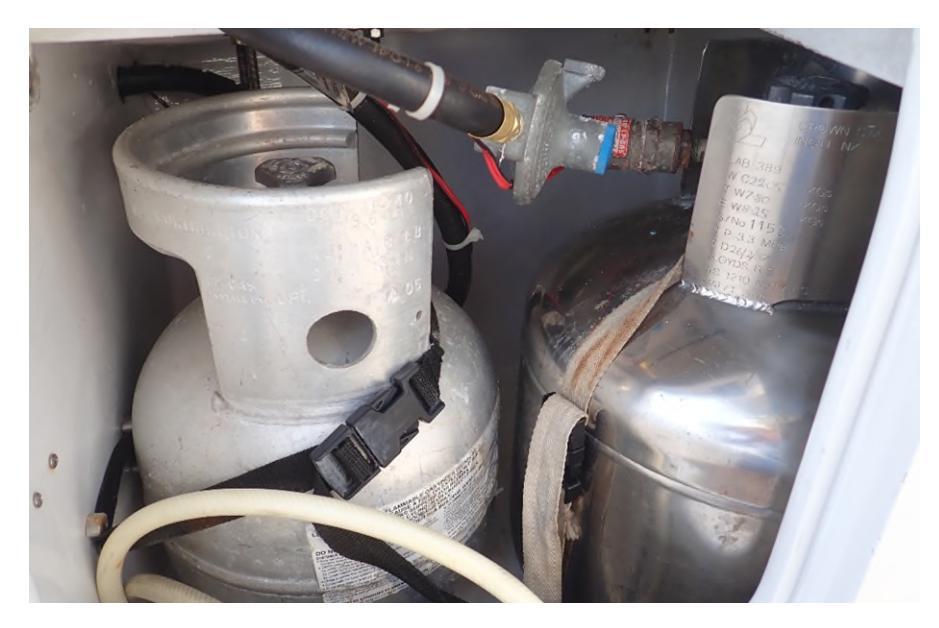
The vessel is equipped a Force 10 three-burner LPG fueled marine range. The readily accessible fuel shutoff valve was tested, and found operable. Inspection of the LPG fuel delivery system showed the fuel cylinder installed within a compliant vented locker. The fuel delivery system is not fitted with a pressure gauge, as recommended by ABYC A-1:

A-1.5.2 Each system shall be fitted with a pressure gauge. The gauge shall read the cylinder pressure side of the pressure regulator.

Further inspection showed the system equipped with two fuel cylinders. One of the fuel cylinders is not DOT approved, nor was this cylinder fitted with OPD valve, as recommended by DOT regulations.

- 1. Verify the condition of the holding tank macerator discharge sea-connection.
- 2. Replace the non-DOT approved LPG cylinder, with an approved cylinder fitted with an OPD valve.

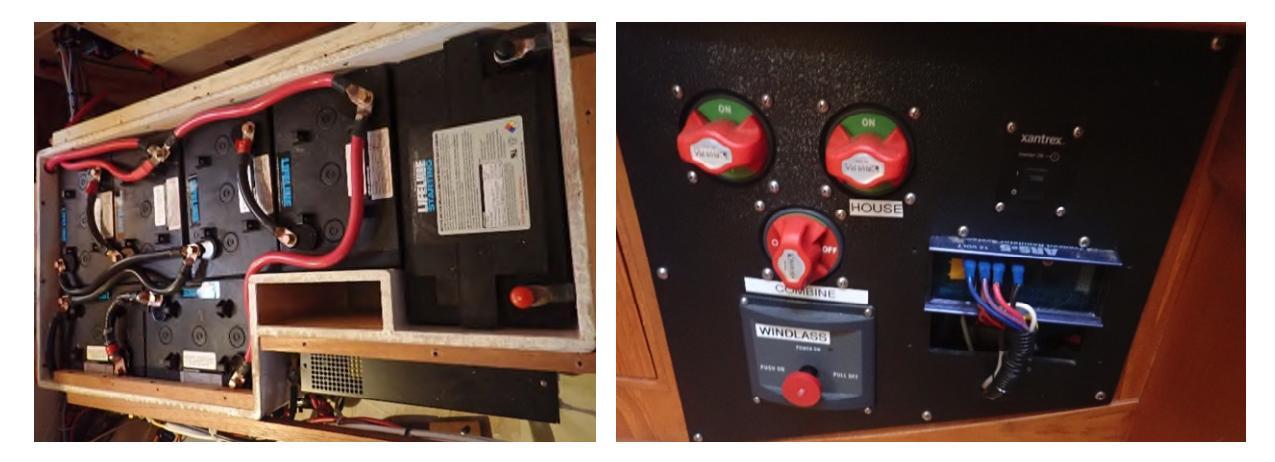
The DC electrical system is powered via the six AGM lifeline batteries, wired in series/parallel, to make the house bank, and the 12-volt AGM engine starting battery, which are routed through the Blue Seas vapor-tight battery switches, and the DC distribution panelboard. The batteries are securely installed within a custom-built plywood box. The batteries reportedly are three-years old.

The battery box had no visible means of venting. If an overcharge situation were to occur, perhaps caused by the battery charger not turning off, or a malfunctioning voltage regulator, AGM batteries would develop pressure inside their casing from the byproduct of hydrogen gas, which would discharge through vent caps installed in the batteries. Without the battery box being ventilated, there is a chance hydrogen gas could build up into dangerous and explosive concentrations. Providing a means to adequately vent the box to the vessel's interior is recommended. The vent should be located in the top of the box. Since hydrogen gas is lighter than air, the vent should allow the gases to dissipate into the main cabin and out through natural cabin ventilation. The guidelines of ABYC E-10, Storage Batteries recommends:

- 3. Replace the galley's aft GFCI AC receptacle, with a marine type GFCI receptacle.
- 4. Vent the battery box, per ABYC E-10.
- 5. Install a battery switch on the house batteries' ungrounded conductor, per ABYC E-11.

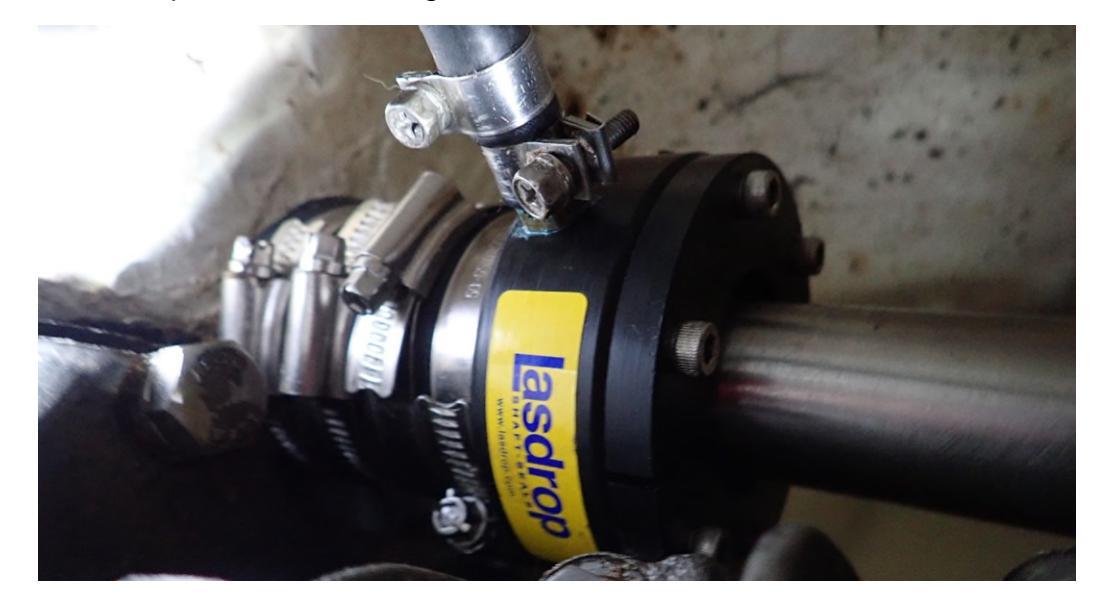
The vessel's propeller shaft relies upon a Lasdrop dripless shaft seal. The seal was weeping when the shaft was at rest, and while turning. The seal reportedly was installed during the recent haul out in the San Diego Driscoll yard. Repairing or replacing the seal so it does not leak is recommended.

- 8. Repair or replace the Lasdrop propeller shaft seal.
- 9. Tension and adjust the steering cables, and fully lock the adjusting studs' nuts.
- 10. Provide at least four currently tagged USCG Type B1 fire extinguishers, and have qualified personnel service and tag the fire extinguishers annually in the future.

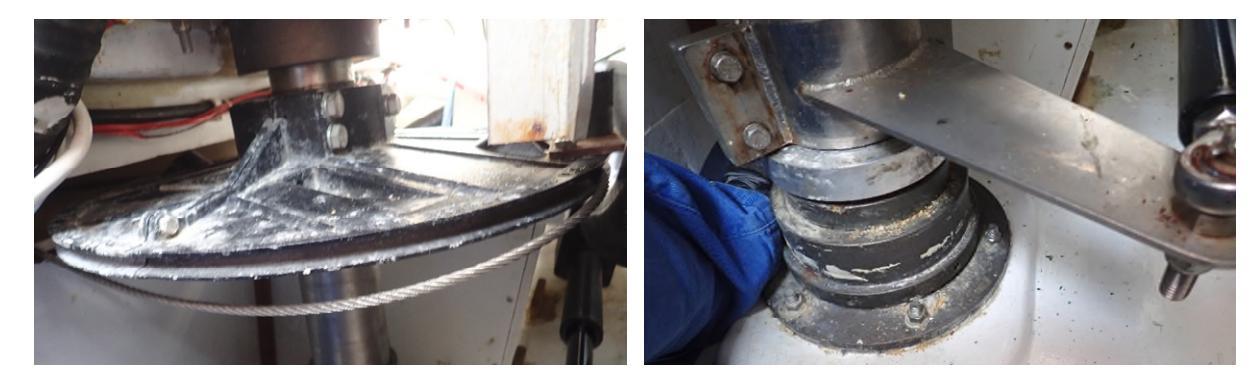
Driscoll Boat Works completed work on the vessel's rudder and steering system, which included repairing the upper bearing and installing new lip seal in the lower rudder bearing assembly. On the delivery to the yard, the Edson pedestal/wheel/cable steering showed excessive play, and the steering was not positive. Inspection of the steering cable showed the cable/quadrant's adjusting studs loose, and the lock nuts not properly tightened. Apparently the cables have been loosening since the rudder was repaired at Driscoll. The cables were slack to the point they could be pulled out of the quadrant, which could have resulted in a loss of steering. Tensioning the steering cables to industry standards, and tightening the adjusting studs' lock nuts is recommended.

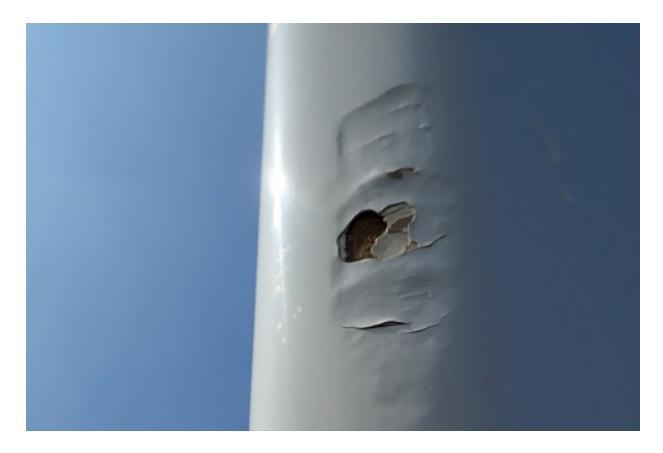
There was a minor area of cosmetic compression damage (shown in below photo), measuring roughly 1" x 3", located just below the stem fitting; perhaps it is from the anchor contacting the stem. Otherwise, the topsides were fair, and free of indentations, physical harm or damage, or indications of previous repairs. The rub-rail is well secured and free of physical damage. The topsides are painted with LPU marine enamel, and were in good condition, maintaining some of their original gloss.

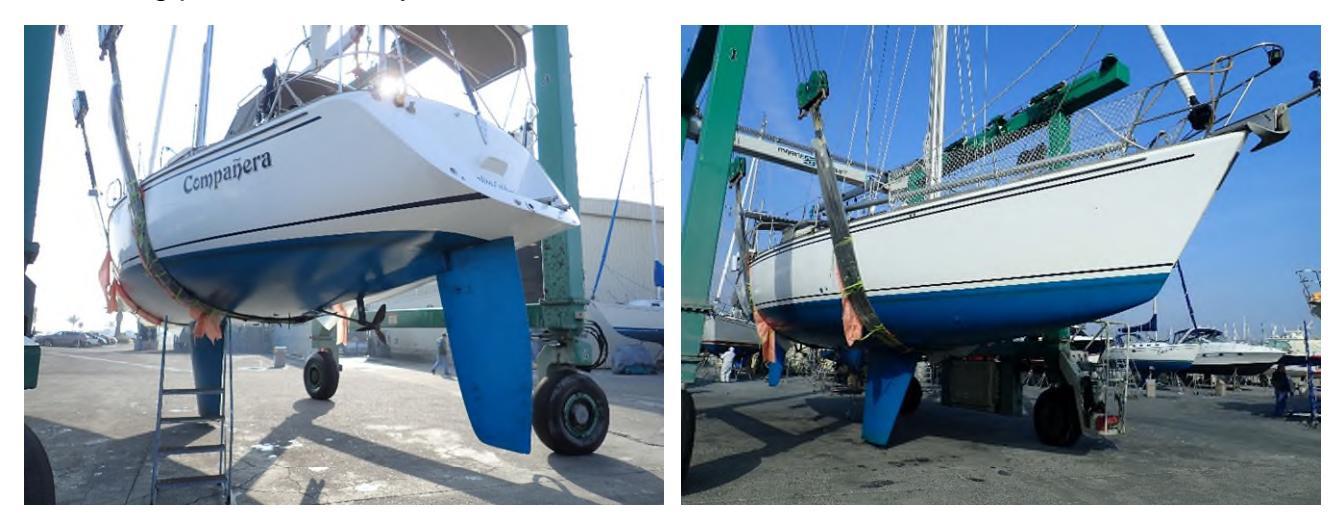
There were areas where the antifouling paint was ineffective, and had thick marine growth, and there were a few other isolated areas where the rolled-on paint was layered. Overall, the antifouling paint was mostly well adhered.

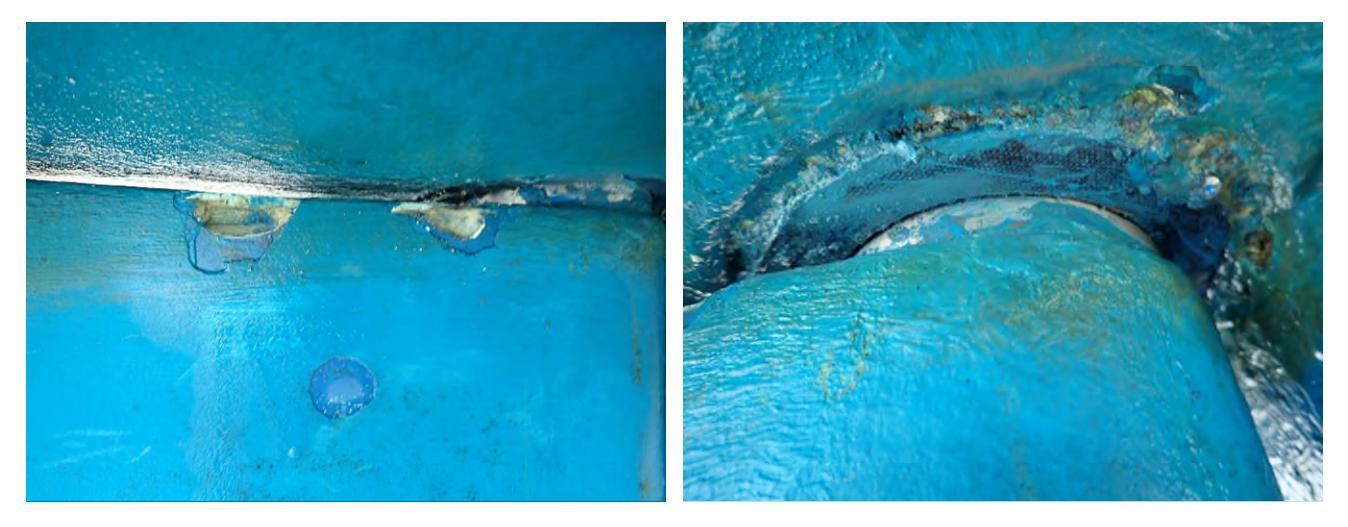
Inspection of the bottom of the keel showed a few areas of bare lead, which should be coated with an underwater epoxy barrier coat. Otherwise, the keel's anticorrosive coatings were in very good condition, with no signs of blistering or detachments. There were no signs of grounding sighted on the foils, or the underwater hull.
