BILL MELBOSTAD, CMS Worldwide Marine Surveys, Ltd.

CONDITION & VALUE SURVEY

S/V COMPAÑERA II

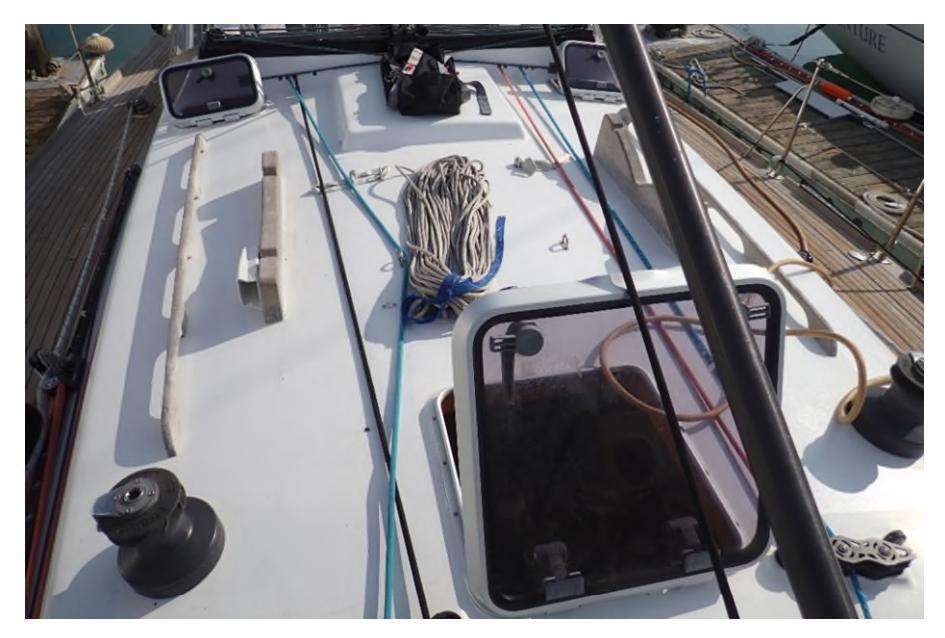
The cabin windows were clear, and free of hazing or occlusions, and well attached to the cabin sides. There are two main opening and three ventilation deck hatches. All their lenses were clear, and free of crazing. Their frames were without cracking, and the gaskets and latching hardware were sealing well.

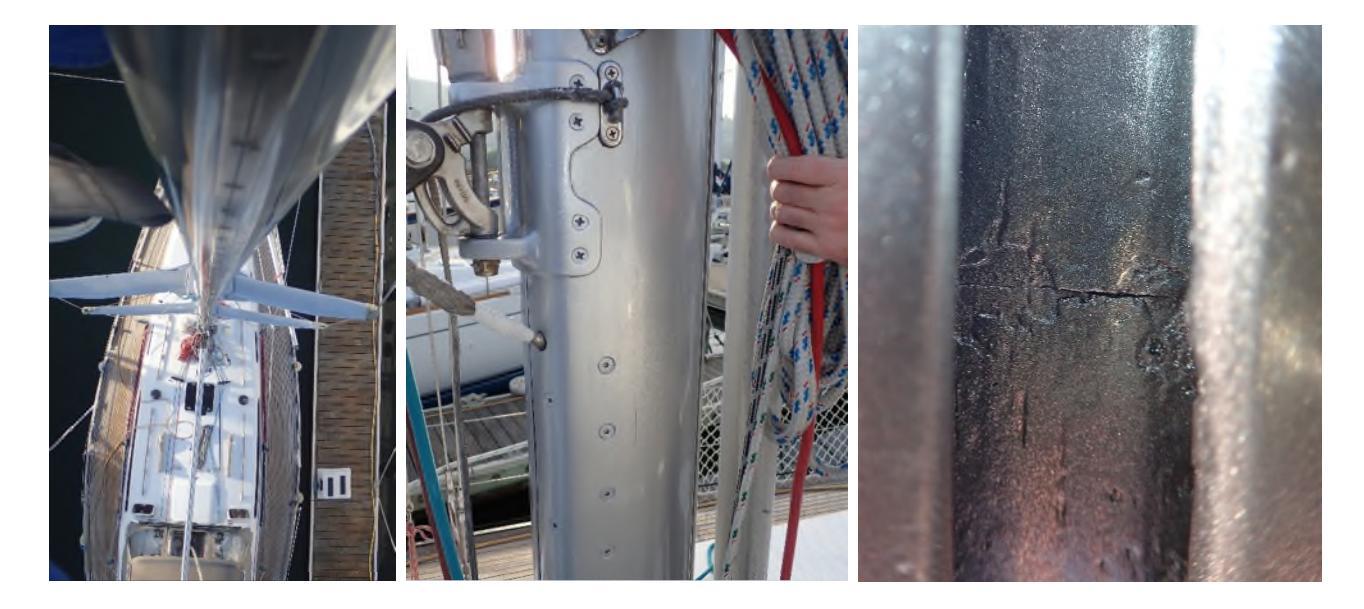
The mast is centered, in-column, and well tuned in the vessel. Inspection of the mast aloft showed no signs of cracking, metal wastage, or pitted aluminum. The double spreaders are installed upon welded brackets that are mechanically fastened to the spar. The spreaders were tight, with no movement at their attachments, and maintaining the correct dihedral angle to the shrouds. The spreader tips were covered with leather chafe gear, and could not be visually inspected. The Antal external sail track was well secured, and tight to the mast. The halyard sheaves all turned freely, and there were no signs of cracking at the welded sheave boxes.

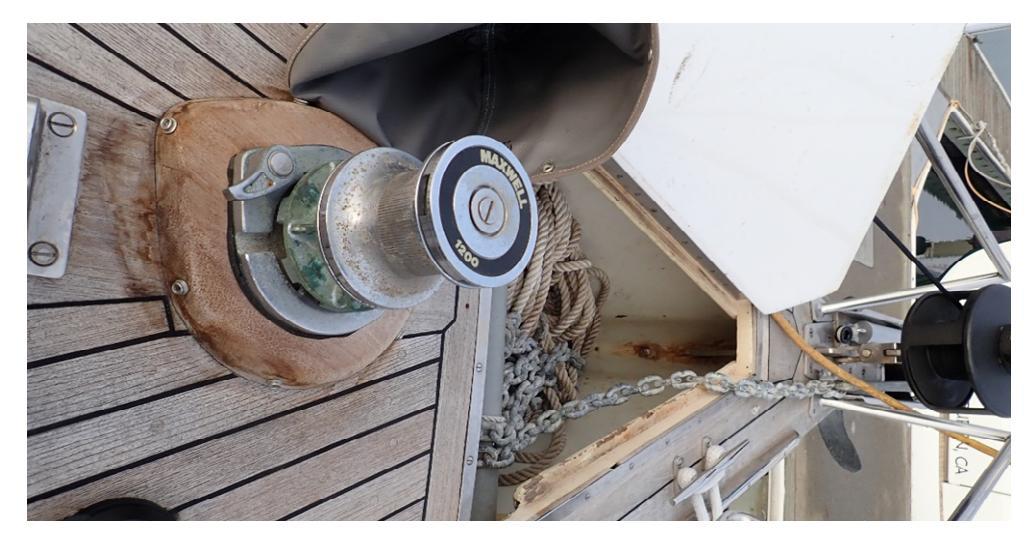
The Bruce anchor, the galvanized chain, and the three-strand nylon anchor rode all appeared adequately sized for most holding conditions, and readily deployable. The Maxwell horizontal capstan anchor windlass, was tested momentarily, without a load, and it powered up as expected.

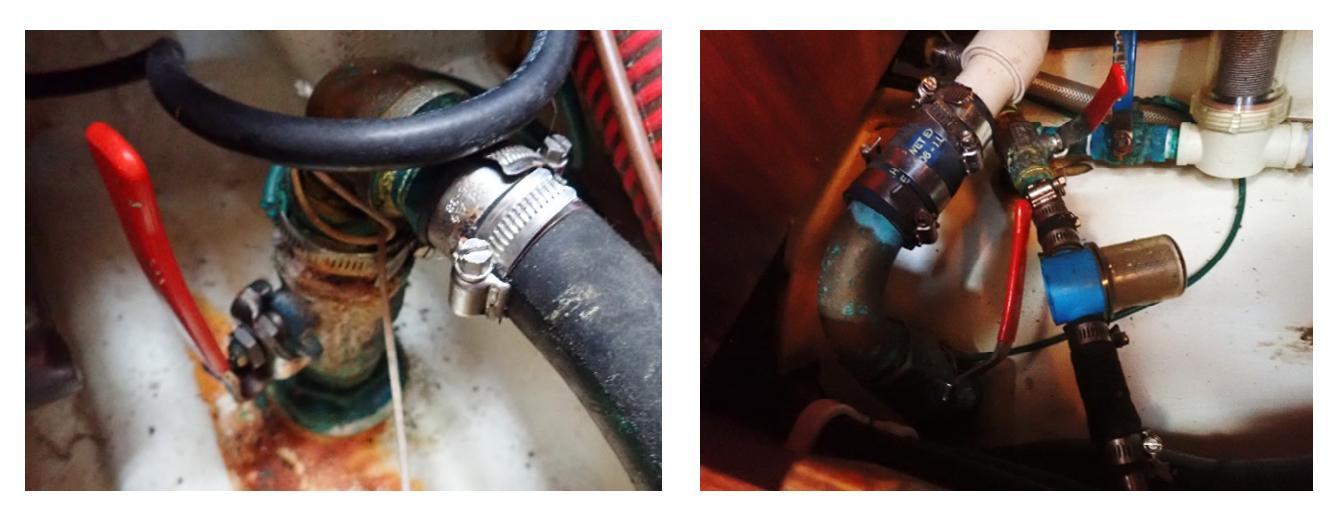
For sea-connections, the vessel relies upon bronze inline ball-valves, coupled to threaded bronze through hulls, and single Forespar Marelon inline ball valve. The engine raw-water intake valve had mild surface corrosion, and the bonding conductor was damaged. The galley sink valve handle was obstructed from closing by an adjacent sea-connection valve. The rest of the sea-connection valves and through hulls were found in operational and satisfactory condition, with no pinking or signs of dealloying on the through hulls and tail piece hardware. However, the macerator discharge sea-connection was not located in the vessel. Verifying its condition and integrity is recommended. All the vessel's corresponding hoses were in satisfactory condition, with no sighted cracking.

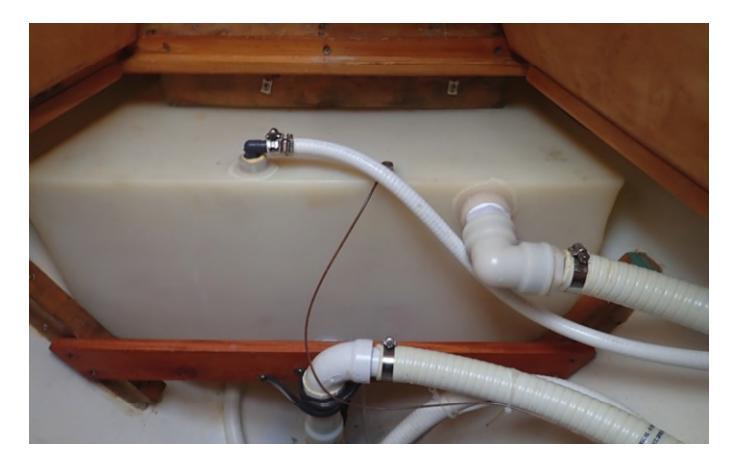
The vessel is equipped with a compliant Type III marine sanitation device (MSD), consisting of a polyethylene holding tank located under the vee-berth in the forward cabin, and the Lavac manual toilet, which alternatively discharges directly overboard or into the holding tank. The holding tank can be emptied via the overboard Macerator pump, and deck pump out plate. Inspection of the MSD found it in satisfactory condition, with no indications of sewage leaks. The MSD diverter valve operated freely, and was in near-new condition. However, there was moderate sewage odor in the forward cabin. It was reported the holding tank vent line was clogged, and attributable to the sewage odor. The buyer reported the holding tank vent line has been cleared. The Lavac head pumped water into and out of the bowl normally.

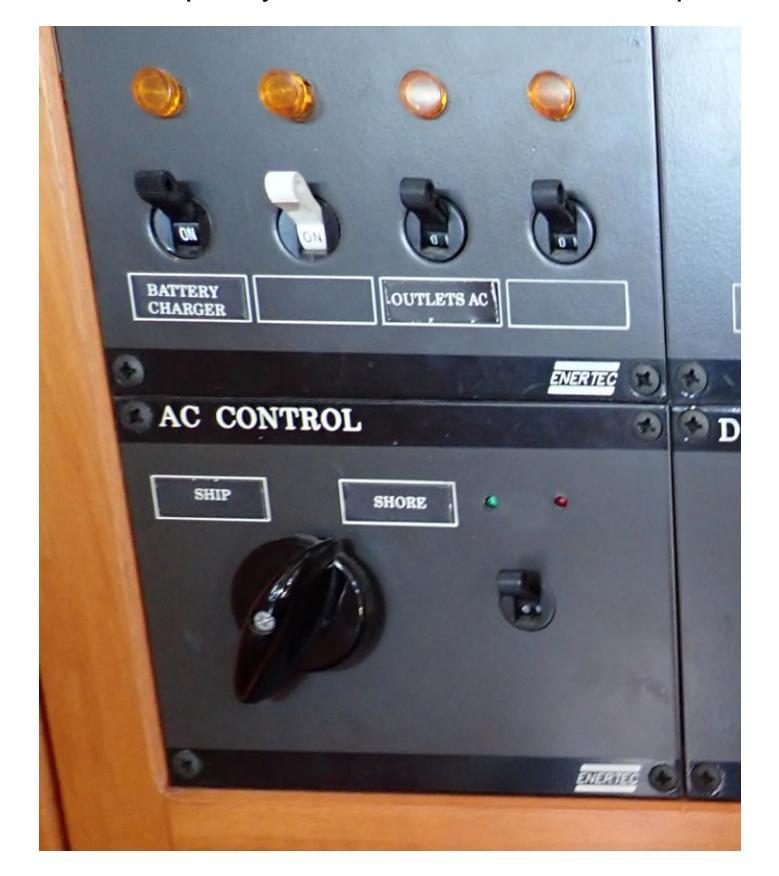
The AC electrical systems are powered via the 30-amp shore power inlet, and routed through the distribution panelboard. The AC electrical systems were tested, and they operated the appliances normally.

The AC receptacles were tested with an Extech load/circuit tester, and there were no indications of open circuits, ground faults, or reverse polarity conditions. There was a slightly elevated voltage drop, of roughly 6%; the National Electric Code suggests a 5% drop or less. When the aft galley GFCI protected receptacle was tested, it tripped, and would not reset. The forward GFCI receptacle tripped and could be reset normally.

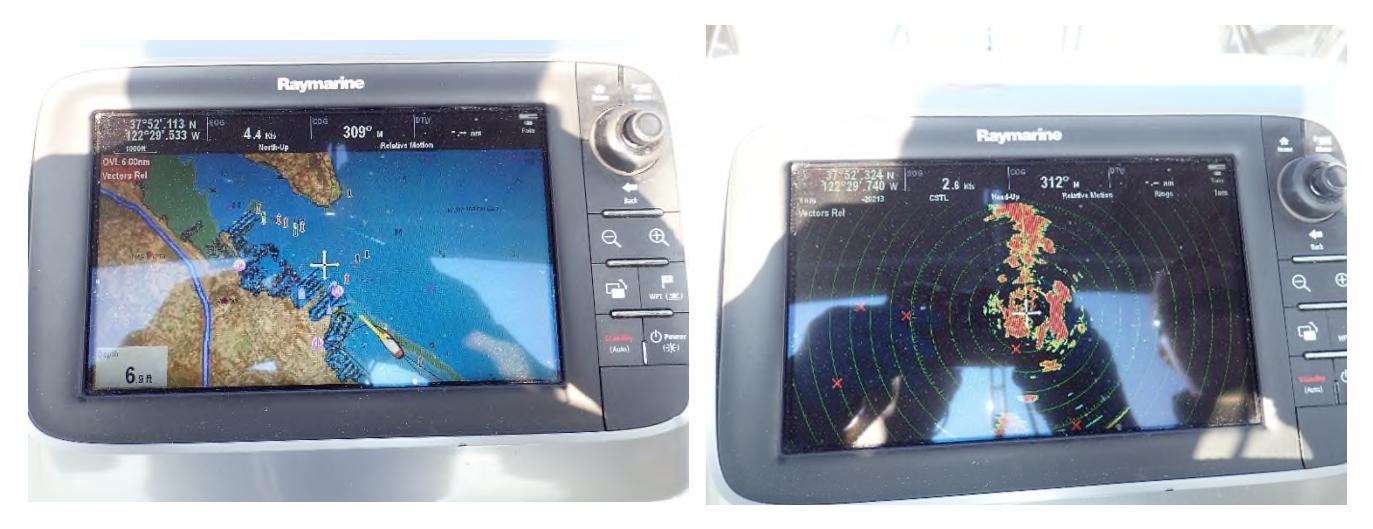
The electronic navigation equipment was tested. The Raymarine E-Series multifunction display (MFD) was powered up and provided accurate navigation information, and vessel position. The MFD provided a clear image when operated in radar mode. The Raymarine sailing instruments were tested, and they provided accurate wind point & speed, and depth information. The Raymarine knotmeter could not be tested, since the impellor was not installed.

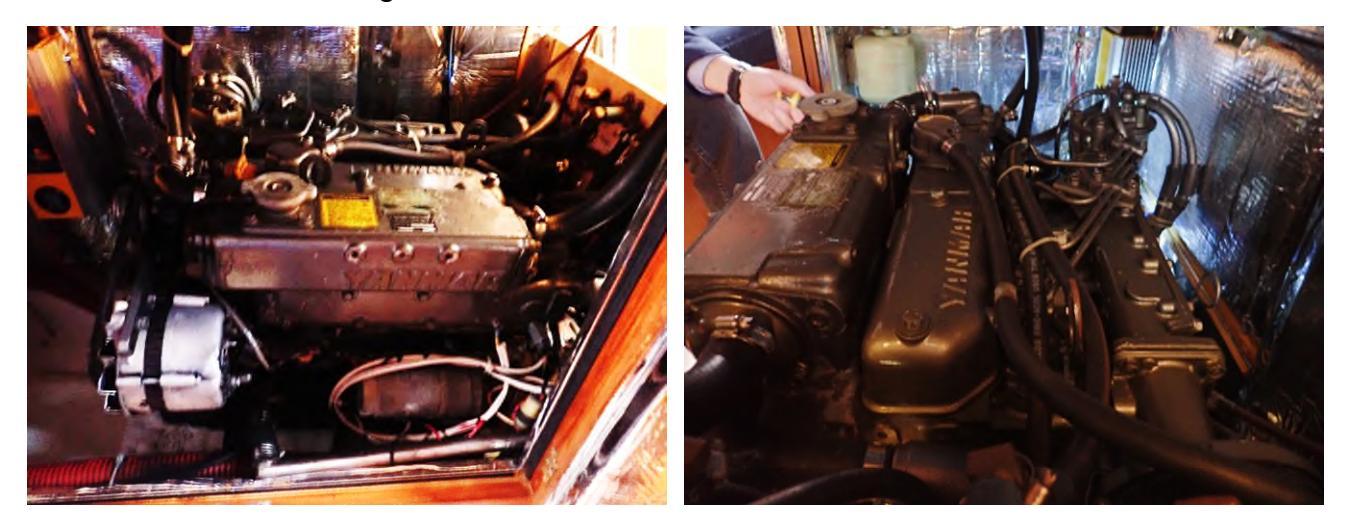
Cosmetically, the engine is in good condition, with the factory installed anticorrosive coatings free of significant failures. The fluids were checked, and the oil and coolant levels and qualities were found normal. The vee-drive's fluid could not be checked, as the dipstick was quite tight in the gear casing, and the surveyor could not remove the dipstick. Verifying the quality and level of the vee-drive's oil is suggested.

Both of the alternators had loose belts. The smaller Yanmar's stock alternator was very loose, and was adjusted and tightened by the prospective buyer. The engine hoses were found in satisfactory condition, with no sighted cracking or wear.

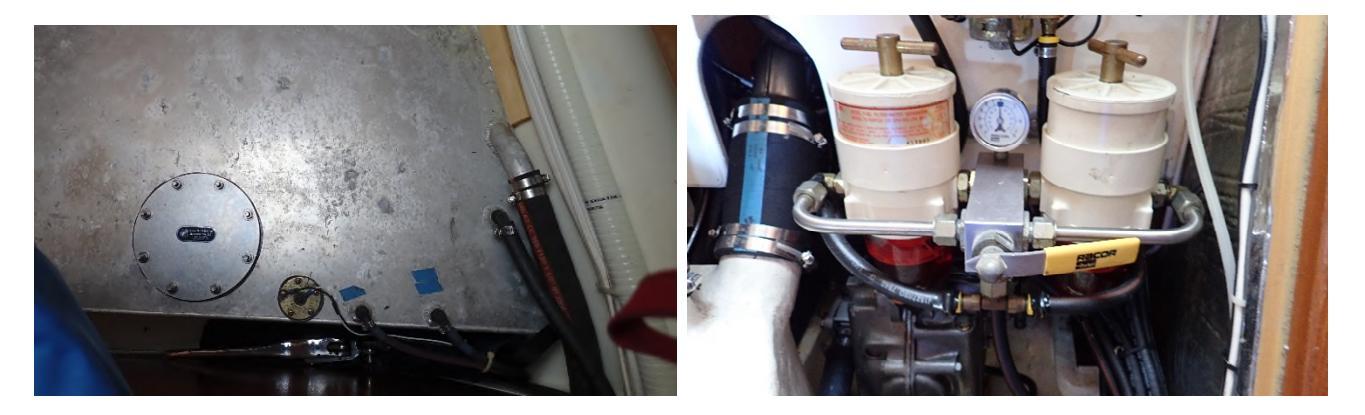
The fuel system consists of two aluminum tanks, and routed through ISO or USCG neoprene flexible fuel hose, and the Racor dual filter water separating tank selector manifold. Reportedly, there has been water contamination in the forward tank, possibly caused by an incorrectly installed vent line. The vent does not have a loop to prevent water from back-flushing into the tank. The exterior vent terminus needs to be relocated either aft or onto the deck, where there is less chance of water entering the line. Otherwise, the fuel system was found in satisfactory condition, with no indications fuel leaks, or fuel odors in the bilges. The two Racor filters' sediment bowls were free of particulate or water contamination.

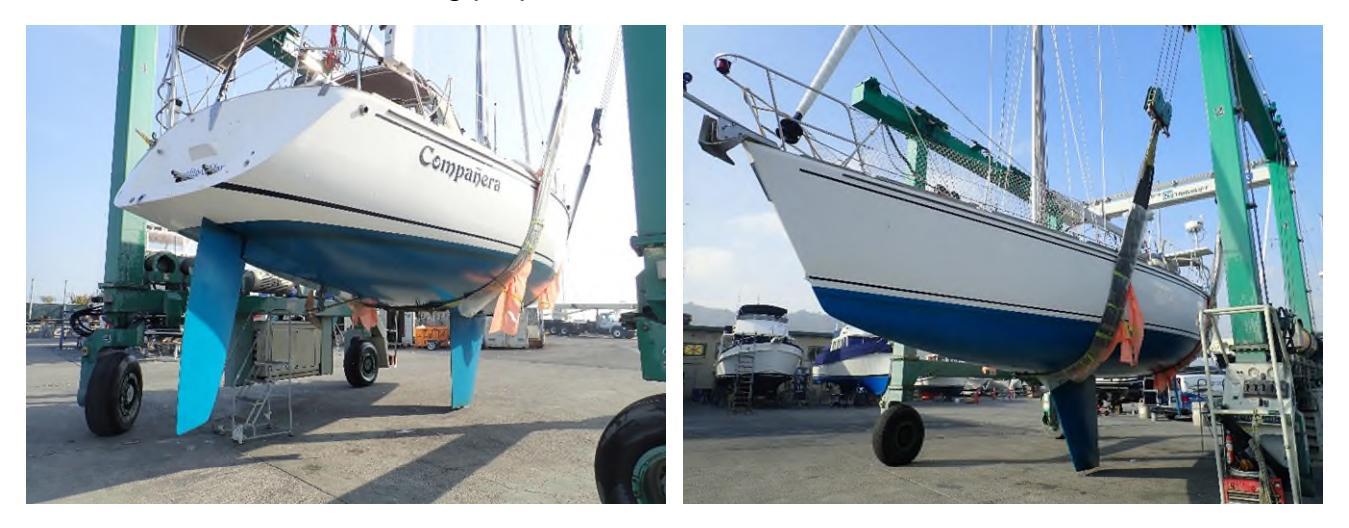
There was a minor area of cosmetic compression damage (shown in below photo), measuring roughly 1" x 3", located just below the stem fitting; perhaps it is from the anchor contacting the stem. Otherwise, the topsides were fair, and free of indentations, physical harm or damage, or indications of previous repairs. The rub-rail is well secured and free of physical damage. The topsides are painted with LPU marine enamel, and were in good condition, maintaining some of their original gloss.

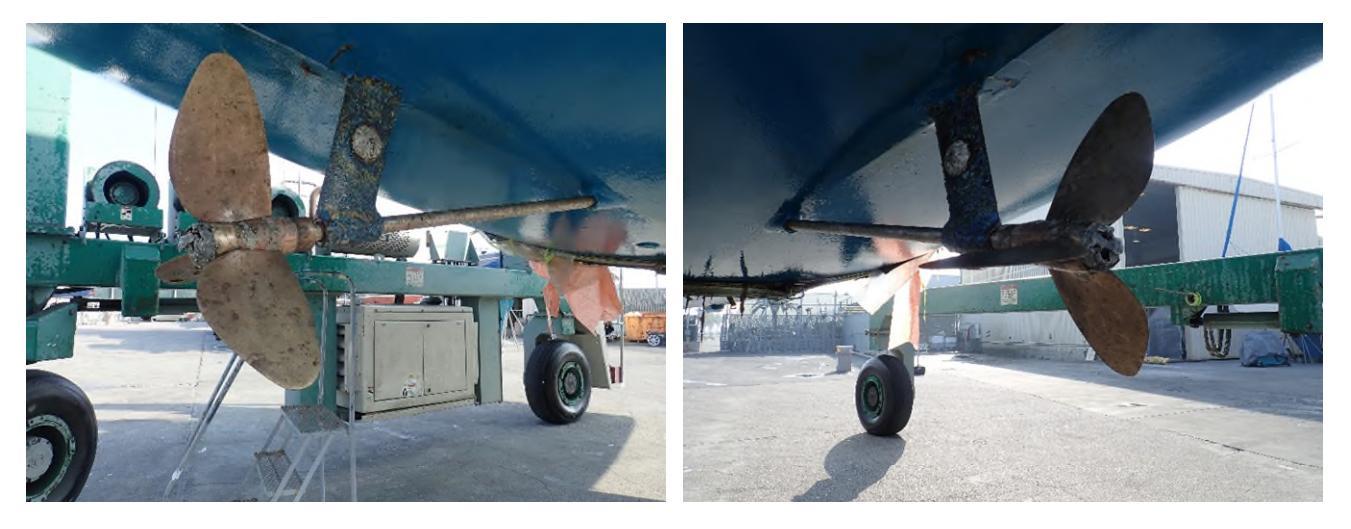
The running gear was found true to the eye. The stainless steel propeller shaft turned easily, was centered in the cutlass bearings, and free of pitting, and other forms of corrosion, or wear, where visible. The bronze three-bladed feathering Max-Prop was in good condition, with no indications of folded or frayed blade edges. It articulated freely, with no paly at the hub. The propeller was free of pinking or de-alloying. The intermediate and main cutlass bearings were well aligned to the shaft, and were without signs of wear. The bronze tee propeller shaft strut was free of de-alloying; it was tight in its mortise, and had no structural movement. The mortise fairing had a few cosmetic cracks, which could be repaired with marine epoxy fillers.
