**CONDITION & VALUE SURVEY**

***M/V 65' Pacific Mariner***

**Report #:** 20-191  
**Date:** Xxxx, XX, 2020  
**Owner:** Big Boat LLC,  
**Survey Requested By:** Steve Smith, [bmelbo@comcast.net](mailto:bmelbo@comcast.net)  
**Broker(s)**  
**Where Surveyed:** Sausalito Yacht Harbor & Keefe, Kaplan, Maritime, INC, in Richmond, CA  
**Afloat/Hauled:** Afloat & while hanging in the Travelift slings  
**Vessel Name:** XXX CCCCC  
**Type:** Pilothouse power cruiser  
**Service:** Private/pleasure  
**Home Port:** Tiburon, CA  
**Photo of Official#**  
**Official #:** XXXXXXXX  
**Photo of HIN**  
**Hull ID#:** XXXXXXXXXX  
**Builder:** Westport  
**Designer:** William Garden  
**Model:** 65' Pacific Mariner  
**Model Year:** 2006  
**Date Last Hauled:** 2019  
**LOA:** 65' 0" on deck (70' LOA)  
**Beam:** 17' 3"  
**Draft:** 5' 0"  
**Displacement:** 69,000 Lbs.  
**Vessel Color Scheme:** White topsides & decks, black stripes

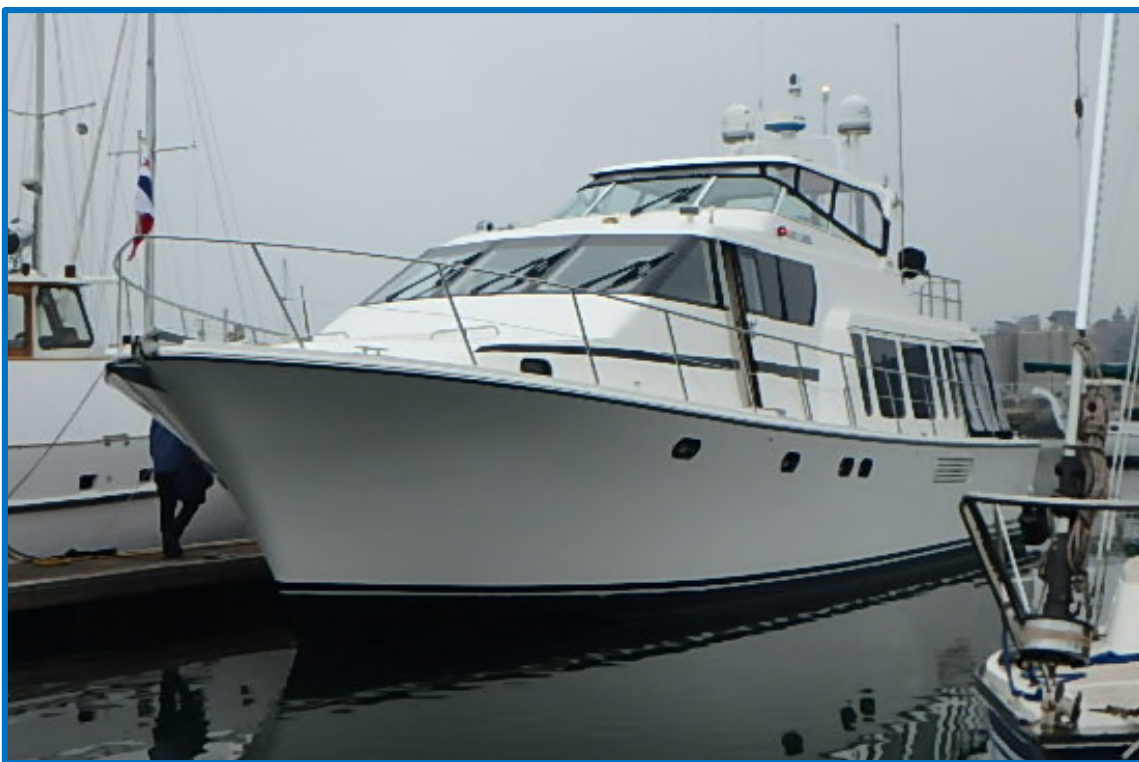
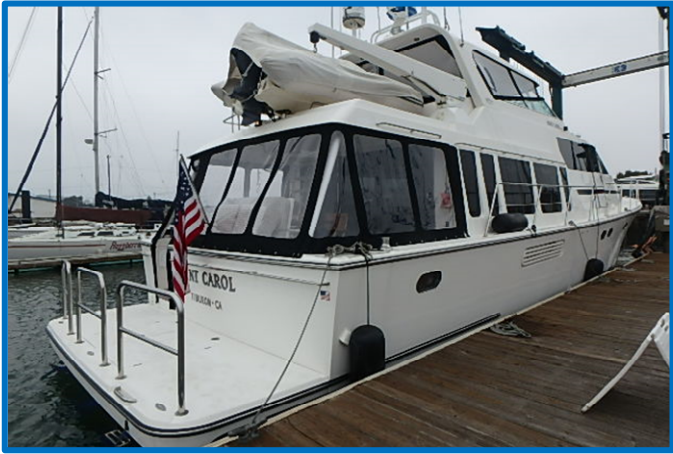
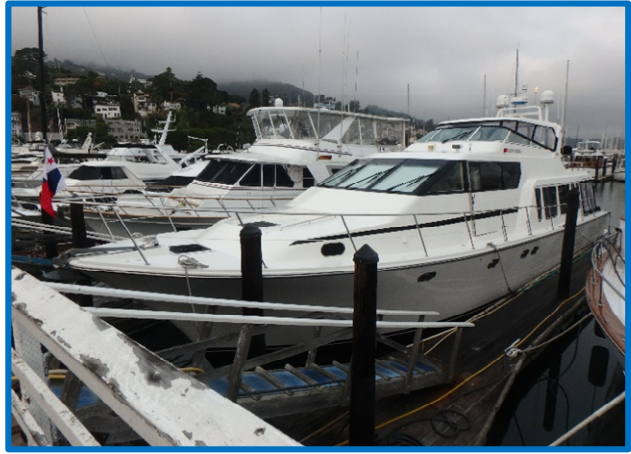
The subject vessel, *Saint Carol*, is a 65' Pacific Mariner, from a proven design by William Garden, and of tested construction from Westport Yachts, of Anacortes, WN. The vessel's intended purpose is for offshore and coastal cruising. Cosmetically, the vessel appeared in very good condition, with the exterior coatings free of noticeable thin cracking, and maintaining much of its original gloss. The molded nonskid was showing good bite.

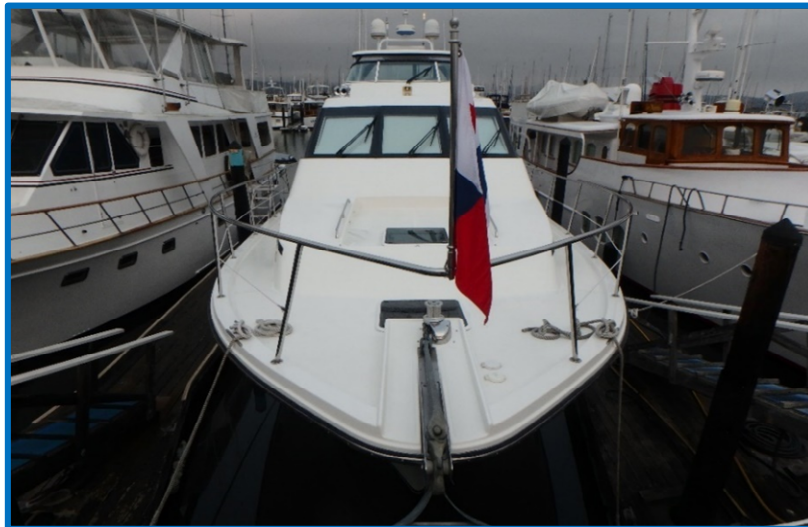
The deck layout consists of a self-bailing aft cockpit, and a flying bridge with a centerline helm station, protected by an isinglass enclosure and a hardtop. There is a boat deck aft of the flying bridge, and flush side and fore decks, and a raised trunk cabin. The deck and cabin structures are constructed with alternating layers of molded fiberglass, with suspected end-grain Balsa core in places for reinforcements. Visual inspection showed the structures without indications of physical harm or damage, or indications of previous repairs. The cockpit sole has a solid teak plank overlay, bonded to the fiberglass substrates. The teak overlay was free of significant eroded or raised grain, shrinking caulking, or cracked planking; it was well oiled and showed a nice golden-brown color. The structures were tap-tested with a 4-oz. ball-peen hammer; there were no indications of outer-bond separations, delamination, or signs of deteriorated core materials. Tap-testing also showed no debonded teak planking on the cockpit sole's teak overlay. The structures were spot-checked with a Protimeter Aquant moisture-meter; all readings were generally low, with no indications of water migration into the composite structures, or saturated core materials.

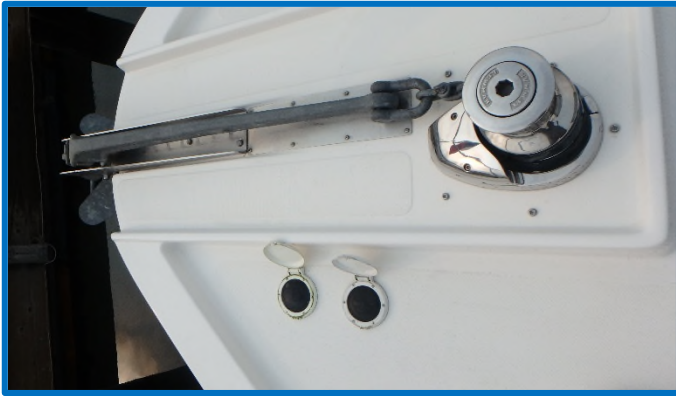
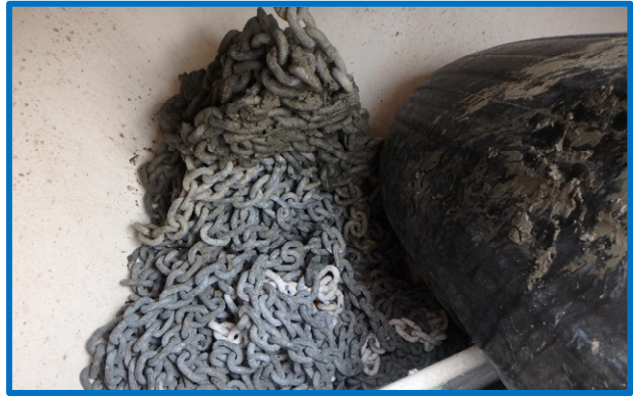
The CQR plow anchor and the galvanized chain appeared adequately sized for most holding conditions. The Lewmar vertical capstan anchor windlass was tested momentarily, without a load, and it powered up as expected. The aft windlass foot pedal control cover had a broken hinge. The aft side decks are equipped with Lewmar vertical capstan winches; these winches were tested momentarily without a load, and they powered up as expected. The anchor chain was not paid out, inspected, or measured; nor was the chain sighted as being terminated in the anchor locker. Inspection of the chain locker showed some bay mud caked onto the chain. Otherwise, the anchor locker was mostly clean and appearing to drain well, and the chain was free of rusting or galvanizing failures.

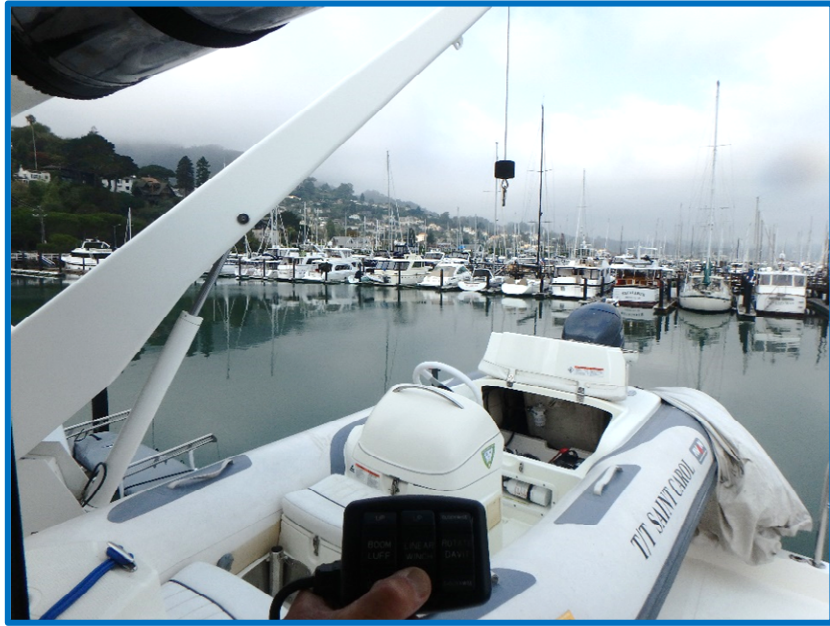
The vessel is equipped with an Avon center console rigid inflatable dinghy, powered via a Yamaha 40-HP four-cycle engine. The dinghy was not test-run, or operated by the surveyor; its running condition is unknown. Inspection of the dinghy showed the normally expected aging of the suspected Hypalon fabric collar, and only minor fading, but it was free of cracking or noticeable UV damage, or significant abrasions. The collar was found firm, with adequate inflation, and well vulcanized to the fiberglass hull. The dinghy's rigid underwater hull was fair, and free of indentations, physical harm, or damage. The cockpit vinyl upholstery was in good condition, and free of significant UV damage or tearing. The Yamaha outboard cowling was without damage, and its coatings were maintaining good gloss. The outboard's tilt and trim system was functioning normally, and its pump assembly was without corrosion or leaking piston seals. The battery was just replaced, and had a 2020 date stamp. The mechanical push/pull steering was smooth, positive, and friction-free. The engine's wiring harness loom is UV damaged, and should be replaced. The stern navigation light was damaged, and not operable. The dinghy's fire extinguisher was manufactured in 2015, and is not currently tagged.

The dinghy is launched via an aluminum hydraulic/electric davit. Inspection of the davit showed it without physical movement, and well secured. The davit was tested, and its hydraulic cylinder lifted the davit normally, without a load, and the DC lifting winch functioned normally. However, the davit's sheaves were slightly slow to turn, and the cable was not turning easily over them; they may need lubrication. The davit's wired remote control was without damage, or corrosion.

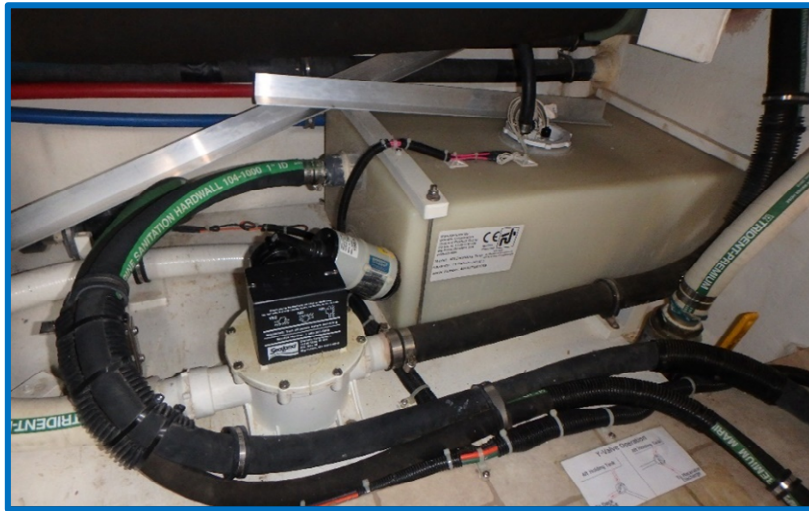
The vessel is equipped with two compliant Type III marine sanitation devices (MSD). The crew quarter's MSD, which services the electric Jabsco toilet, uses a polyethylene holding tank, which can be emptied via the deck plate pump, or overboard via the Sealand macerator pump. The crew quarter's MSD was in satisfactory condition, with no indications of sewage leaks, or sewage odors. The crew quarter's Jabsco toilet was tested, and it pumped water through its bowl normally. The head's diverter valve was found to operate freely. The crew quarters' macerator pump was not tested.

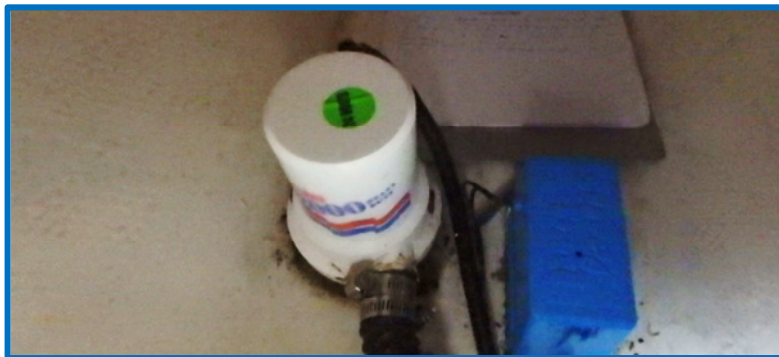
The vessel is equipped with multiple and redundant Rule submersible bilge pumps, all wired with float switches, to make them activate automatically or manually via their helm station mounted toggle controls. The bilge pumps were tested via their float switches, and functioned all as expected. The bilge pumps were not tested from the helm toggle switch controls.

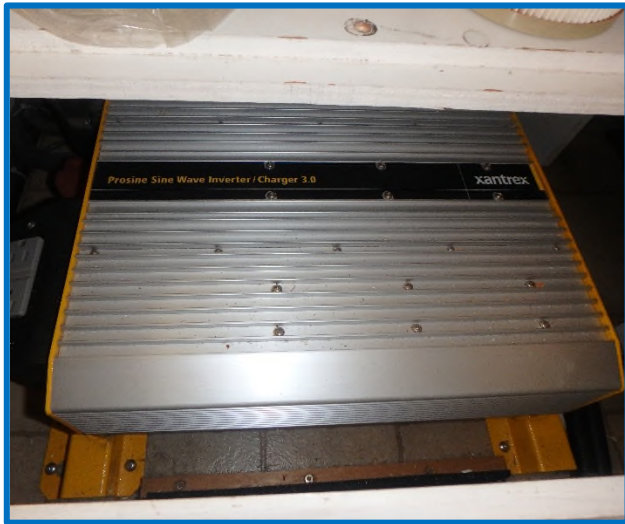
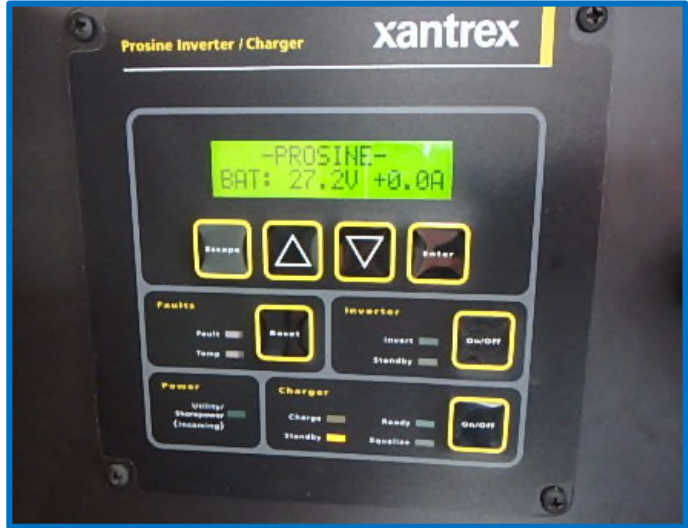
When the AC electrical systems are disconnected from shore power or the generators are offline, a Xantrex Pro Sine 3000-watt inverter/charger automatically comes online; it powers certain appliances, such as the refrigerator, microwave oven, and selected receptacles. The inverter/charger powered the refrigerator and the galley AC receptacles normally. When the vessel is connected to shore power, the inverter goes into passthrough mode.

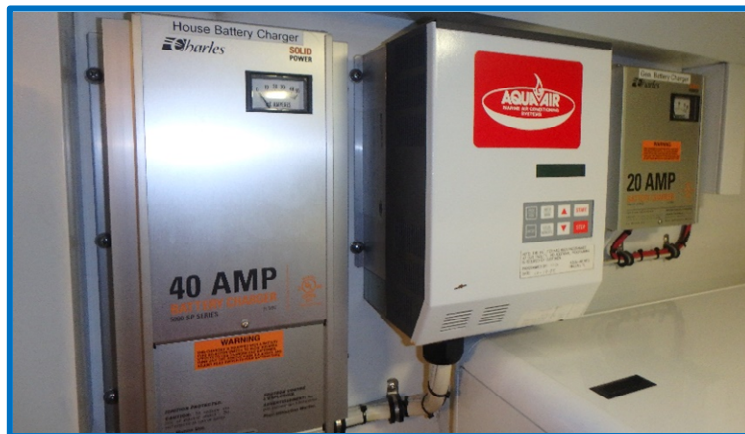
Several of the batteries had date stamps indicating they were installed in 2013. The vessel's Captain reported all the batteries were replaced roughly 3 or 4 years ago. It is typical marine industry practice to replace deep-cycle batteries upon 7- to 10-year cycles, depending on their care, charging profiles, maintenance, usage, and discharge cycles. Upon any indication of low voltage or charging anomalies, replacing the house batteries is suggested. At the time of the inspection, the batteries were charging normally and showed normal voltage levels.

The engine batteries are charged via the Charles 10-amp smart battery charger, and the engine mounted alternators. The house batteries are charged via the Charles 40-amp smart charger, the Xantrex inverter/charger, and the engine mounted alternators. The charging sources were found operable, the chargers functioned normally, and the alternator's output was within specification, and varied between ~26 and ~28 volts, according to the helm mounted volt-meters.

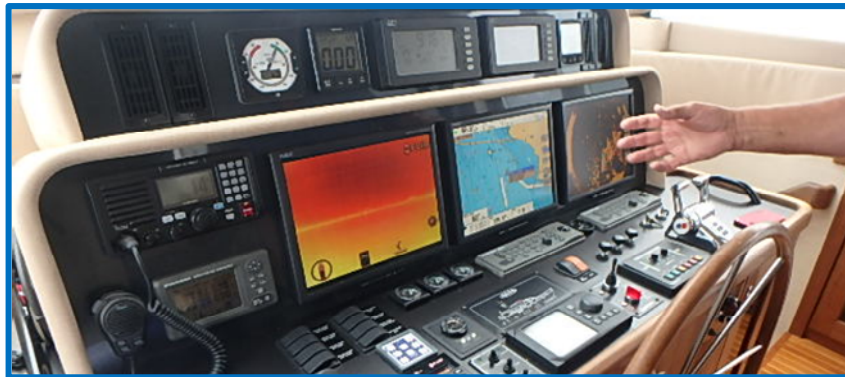
The electronic navigation equipment was tested during the sea-trial. The heart of the pilothouse's primary electronic navigation system are the three NEC-LCD displays, reportedly interfaced with the Furuno GPS and the HP Pavilion CPU loaded with C-Map navigation software. The navigation systems were tested, and when in GPS/plotter mode, the center display provided accurate vessel position, and charting and navigation information. The starboard display provided a clear radar image. Testing the flying bridge helm Furuno multifunction navigation display showed it to power up normally, and provide a clear image in radar mode, and accurate vessel position and navigation info when in plotter/GPS mode. Both ICOM VHF radios powered normally, and received transmissions clearly. The Simrad flying bridge wind, depth, and knot meter displays did not show data. The pilothouse depth sounder powered up, but did not provide depth info.

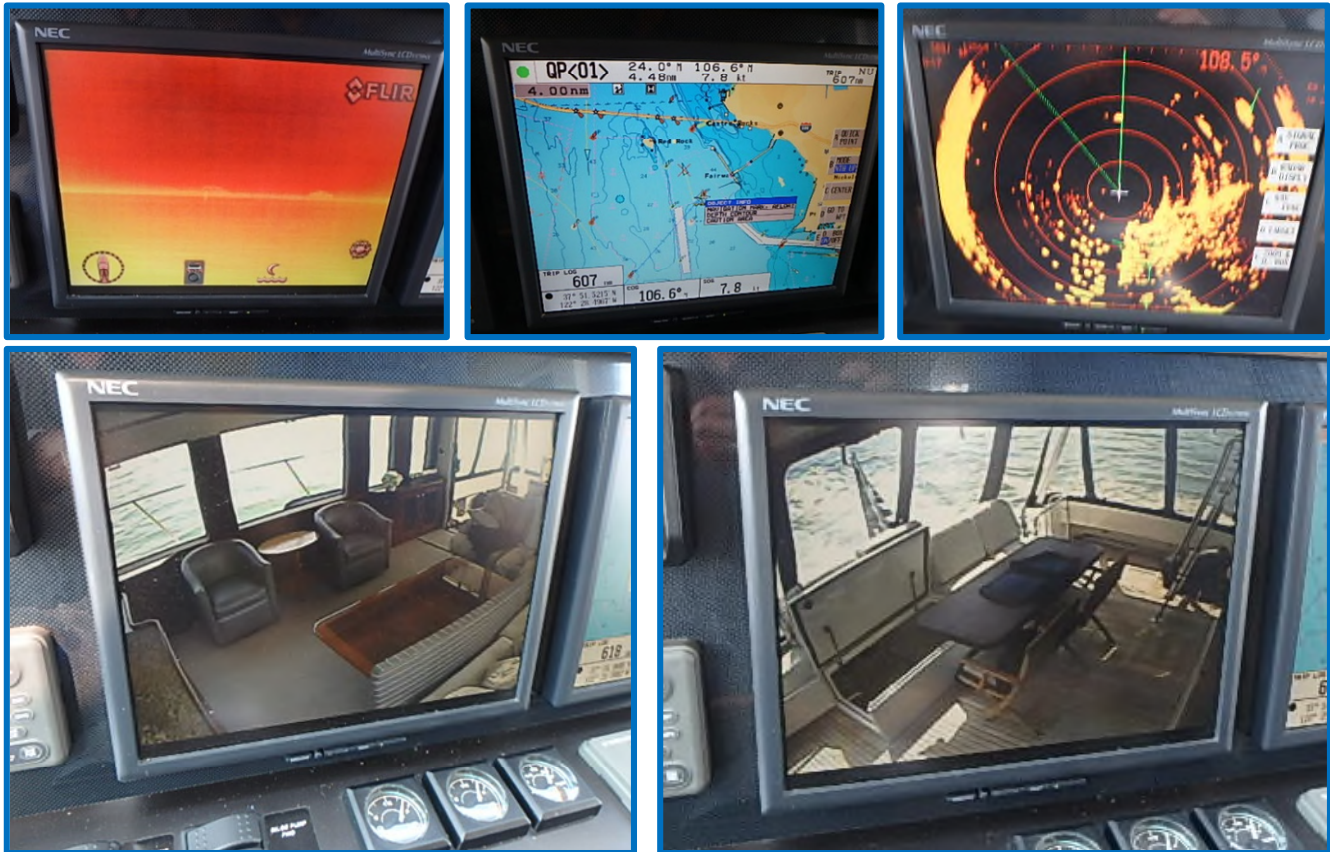
The engine room, aft deck, main salon, and pilothouse are equipped with closed circuit digital video cameras, additionally, there is a mast-mounted Flir night vision camera atop the flying bridge hardtop. The various cameras were tested, and all provided clear images on the port NEC display.

The navigation equipment, the two KVH satellite domes, and the radio antennas on the flying bridge were well secured, and without physical harm or damage. The Satellite domes' aluminum masts had a few inconsequential areas of peeling paint. The split loom protecting the flying bridge mounted antennas and other equipment cabling was UV damaged. The wire loom should be replaced.

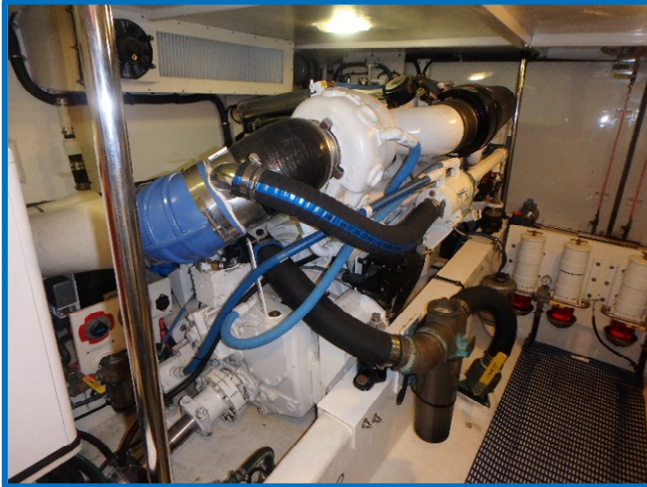
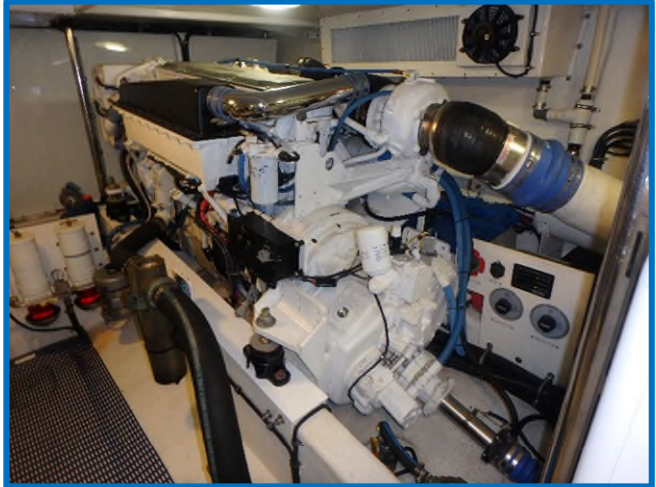
The vessel is powered via twin inline six-cylinder, turbocharged after-cooled Detroit MTU Tier 2 diesel engines, which are coupled to ZF marine reduction gears, and turning stainless steel inline propeller shafts. The engines are securely installed upon fiberglass engine stringers with the use of aluminum channel. The motor mounts are sound and solid, with their bushings maintaining good resiliency, and the adjusting workable, and rust-free. There were no indications of cracking, or delamination sighted on the engine stringers.

Cosmetically, the engines are in very good condition, with their factory installed anticorrosive coatings free of significant failures, or noticeable rust or corrosion on the machinery housings. The fluids were checked, and their levels and qualities were found normal, with the engine and transmission oils clean and amber brown. There was minor raw-water cooling seepage sighted in the following locations:

These minor raw-water leaks should be scheduled for repair.

The engines' oil fills consist of rubber hose cuffs clamped to the dipstick tubes. The hose cuff connections were seeping oil slightly, and the fills need to be repaired. The engine compartment sump had small amount of oil contaminated bilge water, perhaps from a previous engine service. Otherwise, there were no indications of external oil, fuel, or cooling water leaks sighted. The engine accessory belts are mostly concealed behind their protective guards. Where visible, there was a moderate amount of belt dust wear present on the pulleys and the adjacent machinery. The accessory belts should be thoroughly inspected, and replaced if deemed necessary, or per manufacture's periodic maintenance recommendations.

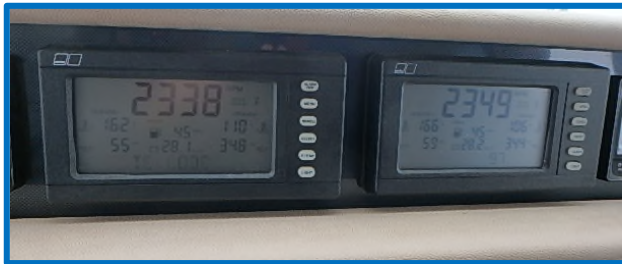
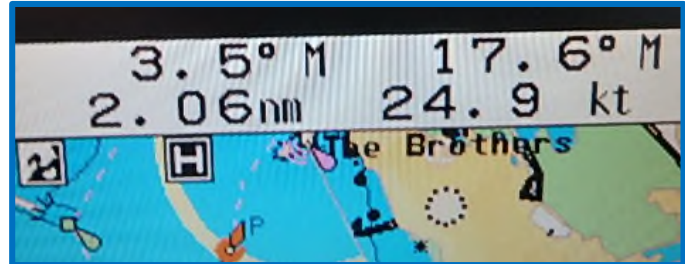
The engines ran exceptionally smoothly at all power-levels, with no unusual vibration, or run-out at the propeller shafts or their seals. The engines were run briefly at full power and wide-open throttle (WOT). At WOT, the engines each attained ~2350 RPM, which meets the manufacturer's recommended WOT RPM rating. The engine controls were operated in single lever synchronization mode, which was functioning normally. At WOT, the engines ran smoothly, with no unusual vibration, or indications of over-fueling exhaust anomalies, and the vessel reached roughly +25 knots, speed over ground, per the vessel's GPS/plotter system.

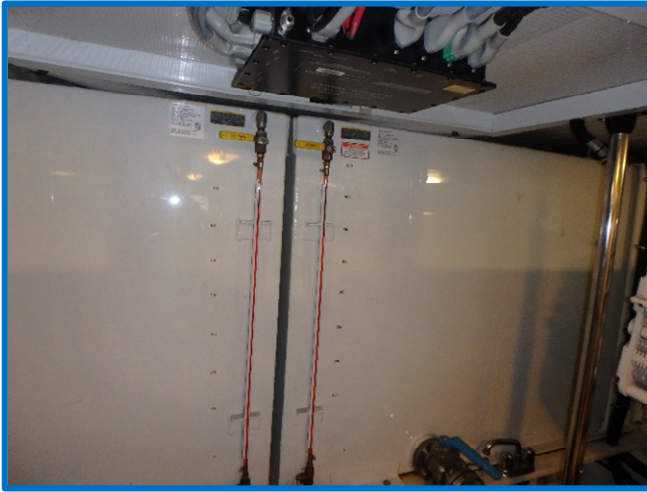
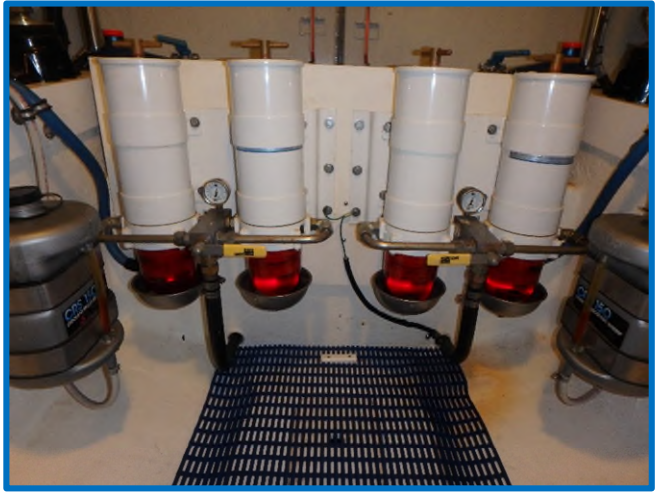
The fuel system consists of two epoxy/LPU coated aluminum alloy self-leveling tanks, drawing and filling from the top, and routed through USCG A-1 flexible neoprene fuel hose, and the four Racor water water/fuel separating filters configured in a manifold. The fuel tanks are fitted with sight tubes equipped with shutoff valves, and pilothouse helm gauge. The fuel gauge readings were consistent with the sight tubes. The fuel systems were in satisfactory condition, with the visible exterior of the fuel tanks' surfaces in near-new condition, and no indications of fuel leakage, or odors in the bilges. Each generator fuel system relies upon a Racor 500MA water/fuel separating filter. All of the filters' sediment bowls were clear, and free of indications of particulate, algae, or water contamination.

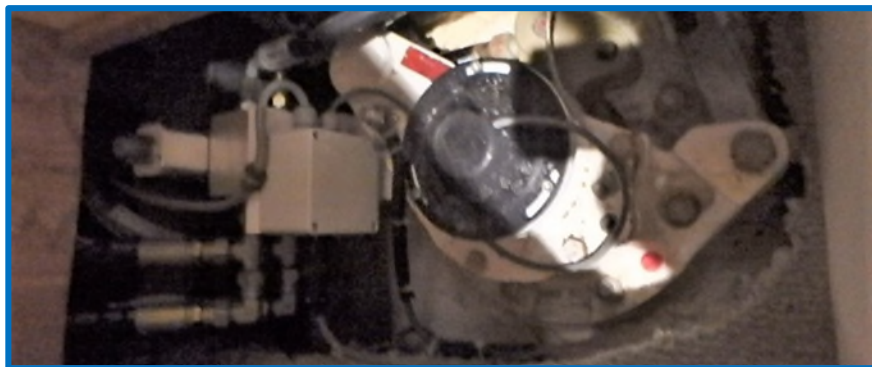
The vessel is equipped with Naiad hydraulic fin type stabilizers, which are powered by a hydraulic pump installed on the starboard engine. Aside from the aforementioned cracked raw-water cooling hoses, the stabilizer system appeared in good working order, and well maintained, with no significant rust or corrosion sighted. The stabilizers' actuators are located in the master stateroom sole; their hydraulic cylinders were observed to be modulating on the run back to Sausalito, and is assumed they are functioning normally.

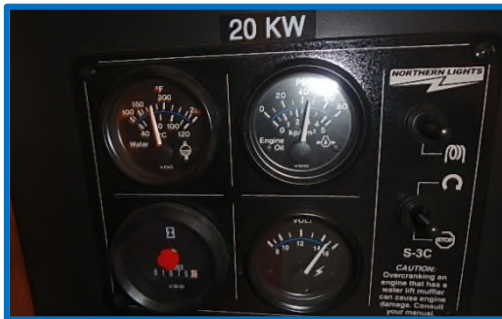
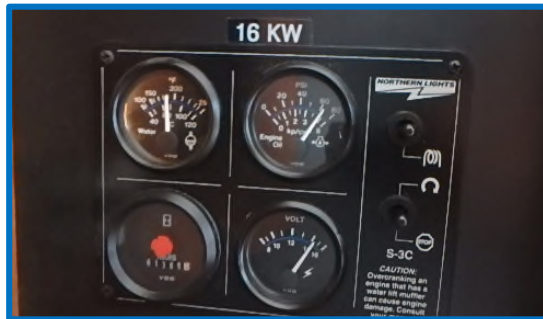
The vessel's 20 KW and 16 KW generators were found in good cosmetic condition, with their factory installed anticorrosive coatings free of failures. The generators' sound shields and their sound proofing were well secured, and free of coating failures. The generators' oil was checked, and it was found topped off and clean in both units. The 20 KW generator's coolant was at the low mark in its saddle tank when cold. The 16 KW generator was at the full mark. Monitoring the coolant levels and assuring it meets the manufacturer's recommendations is suggested. Inspection of the generators' water scrubbing exhaust showed minor cracking of the following hard wall marine exhaust hoses:

- The 16 KW generator's exhaust hose running from the mixing elbow to the water scrubbing water-lock;
- The 20 KW generator's water scrubbing lock center exhaust hose.

These hoses should be scheduled for replacement in the near future. Furthermore, areas of both generator's exhaust systems are concealed and could not be fully inspected by the surveyor. Performing a thorough examination of the generators' exhaust systems, and repairing or replacing as deemed necessary is suggested.

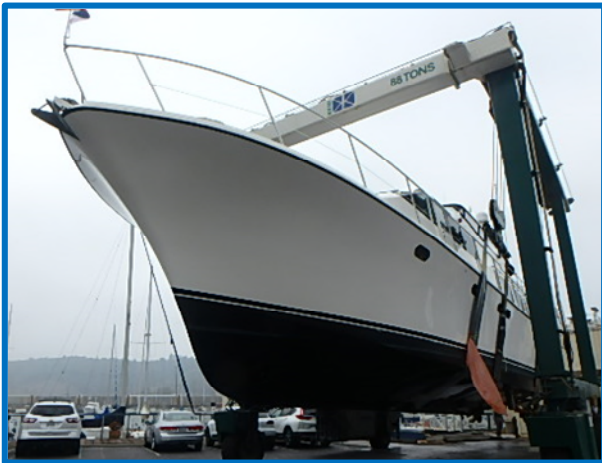
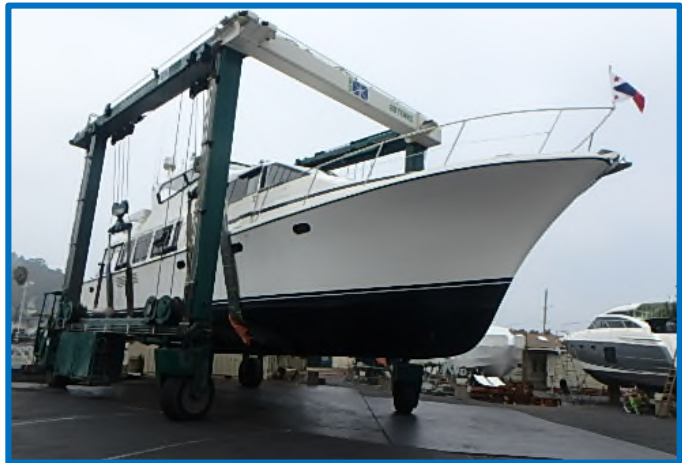
The topsides were fair, and free of indentations, physical harm or damage, or indications of previous repairs. The rub-rail was without impact damage, and secure. The suspected topside gelcoat was well maintained, showing very good gloss, and free of oxidization.

Most of the ablative type antifouling paint was well adhered, and smooth. However, there were areas above the starboard chine, on the port hull, and other random areas, that were showing either some thick and layered paint, or minor detachments and bubbling. This is soft ablative paint, and these anomalies should be able to be remedied with extra prep work to remove the loose paint prior to applying the next layer of antifouling.

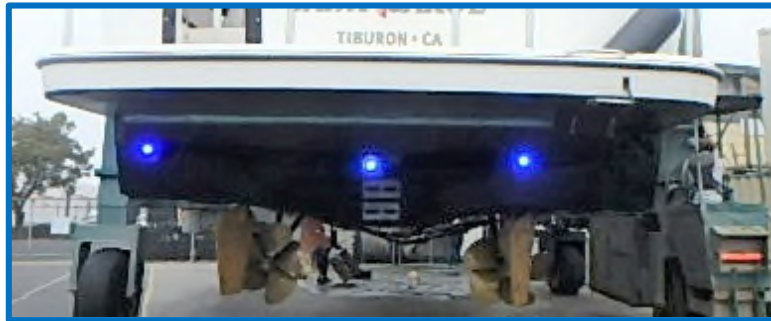
The rudders were well-aligned, tight in their logs, and free of noticeable wobble in their logs. They were without indications of pinking, or dealloying.

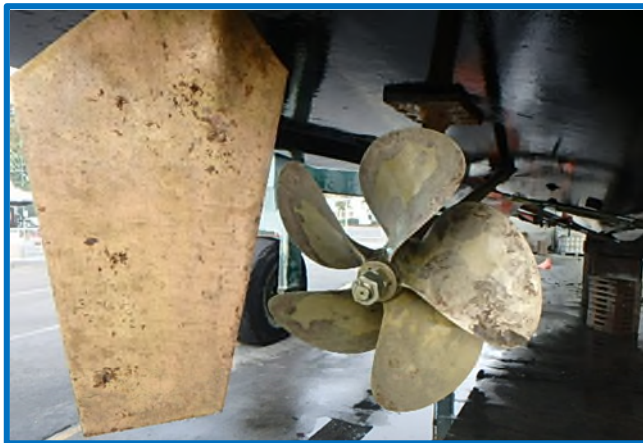
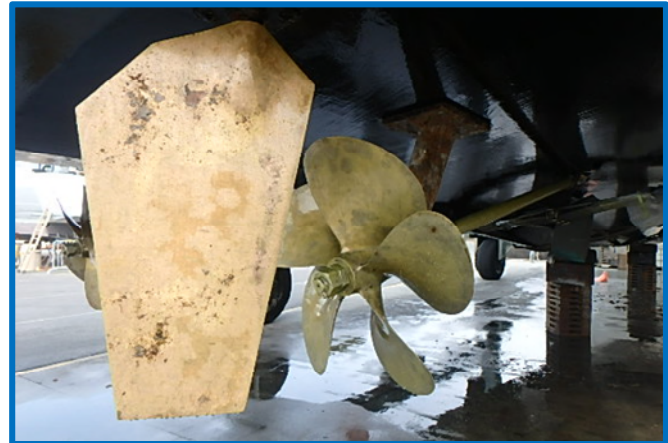
The running gear was true to the eye. The twin stainless steel propeller shafts were centered in their logs and cutlass bearings; they turned easily, and were free of pitting, or other forms of corrosion, or wear, where visible and inspected. The propellers and shafts are coated with Prop Speed, an antifouling coating intended for props and shafts, and other underwater metals. The Prop Speed was effective in preventing calcium carbonate growth, or other forms of hard marine growth, and the running gear was mostly clean. The propellers were in good condition, with no signs de-alloying, pinking, or folded or bent blade edges. The propellers were checked with a straight edge, held at a fixed point, and there were no signs of bent or untrue blades. Both shaft struts were tight to the hull, with no indications of movement. The starboard strut showed minor surface pinking. The cutlass bearings had tight interface to the propeller shafts, and were free of wear.

Aside from the aforementioned minor pinking sighted on the starboard strut, there were no indications of unusual electrolytic activity sighted on the underwater hull. A continuity check was made to determine if the starboard strut was bonded, and it was measured at roughly .5 ohm of resistance, which meets ABYC and industry standards. The bonding system and the underwater anodes appeared to be providing adequate cathodic protection.
